# TRENCHLESS SANS TRANCHÉE Journal

- 🍁 Urban Tunnelling in the City of Ottawa
- 🍁 Pipe Bursting Challenges in the City of St. Catharines
- 🍁 Historic Drinking Water Tunnel Inspection Using Remote Technologies

# Trenchless Point Repair in the GTA: A Cured-in-Place Case Study

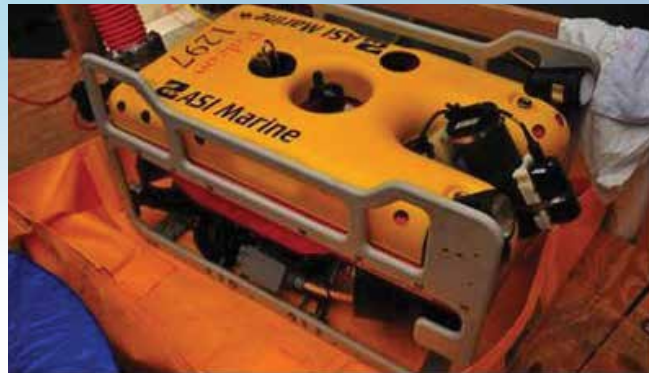
ASI conducted the ROV inspection from two points of access during a planned tunnel outage with client and municipal representatives present to observe the inspection and direct the ROV pilot to areas of interest. ASI utilized its Falcon ROV retrofitted with various data collection technologies, including two-dimensional imaging sonar, profiling sonar, and high-definition video cameras.

Imaging sonar capabilities allowed for detection of tunnel lining damage and/or obstructions (if any) ahead of the ROV. Profiling sonar was used to measure and report any general

tunnel distortion and sediment and debris accumulation along the invert of the tunnel. Video capabilities provided continuous viewing for the duration of the inspection, which was completed within a one-week period.

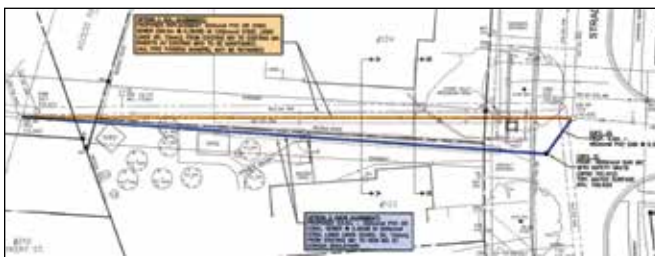
Figure 4. Tender drawing for sewer line replacement.

- In the same location as the existing sewer and reusing both manholes on either end.
- In a new location beside the existing sewer, but reusing one of the existing manholes and installing an intermediate manhole. These options are noted on the below tender drawings, Figures 4 and 5.

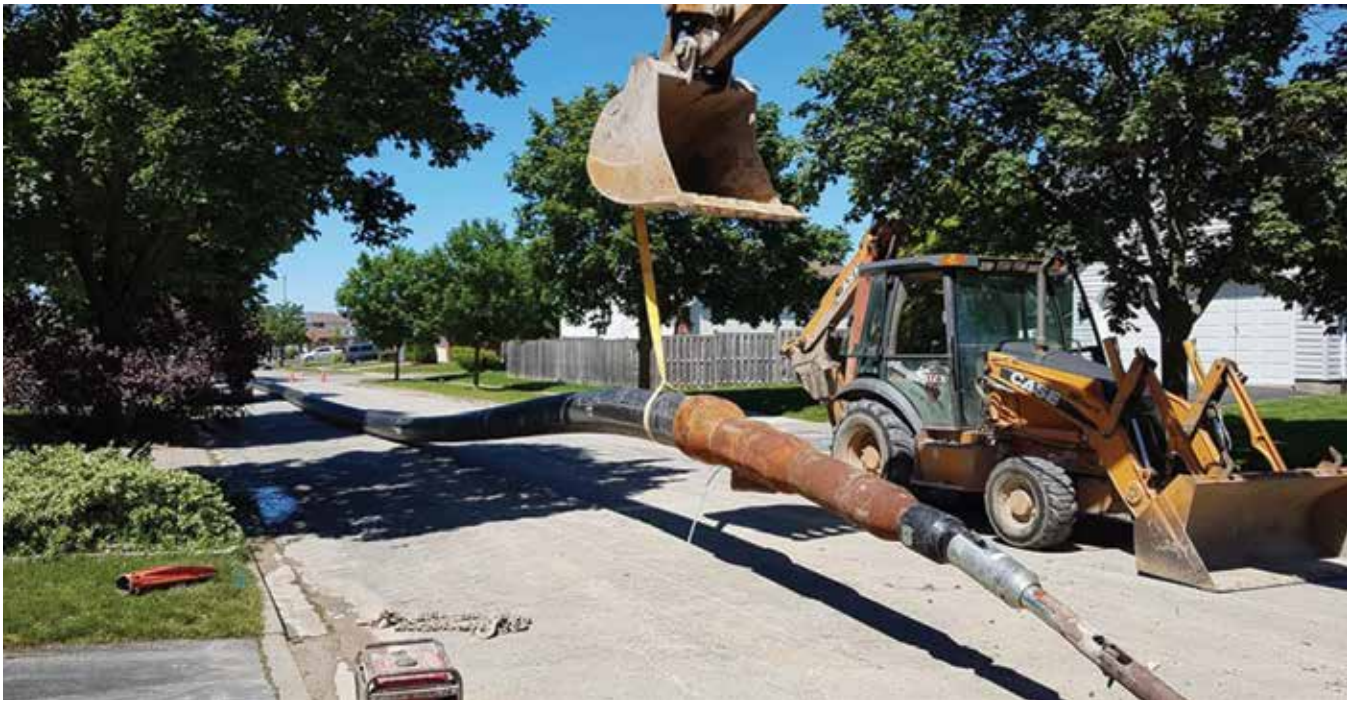
Figure 8. A directional drill was used to create a window down to the existing pipe on the launch side of the project. This allowed Avertex to limited street disruption and restoration.

shaft. A directional drill was used to bore from the surface to the downstream shaft location to allow for pipe installation, Figures 8 to 10.

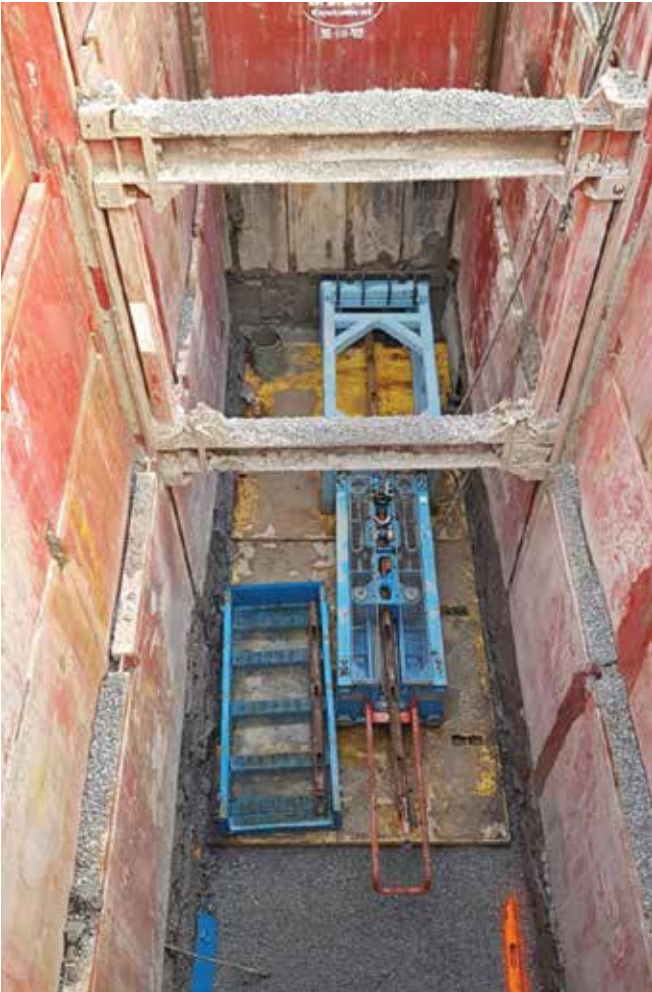
Figure 9. A static pipe bursting unit was used to burst and replace the collapsed PVC pipe.

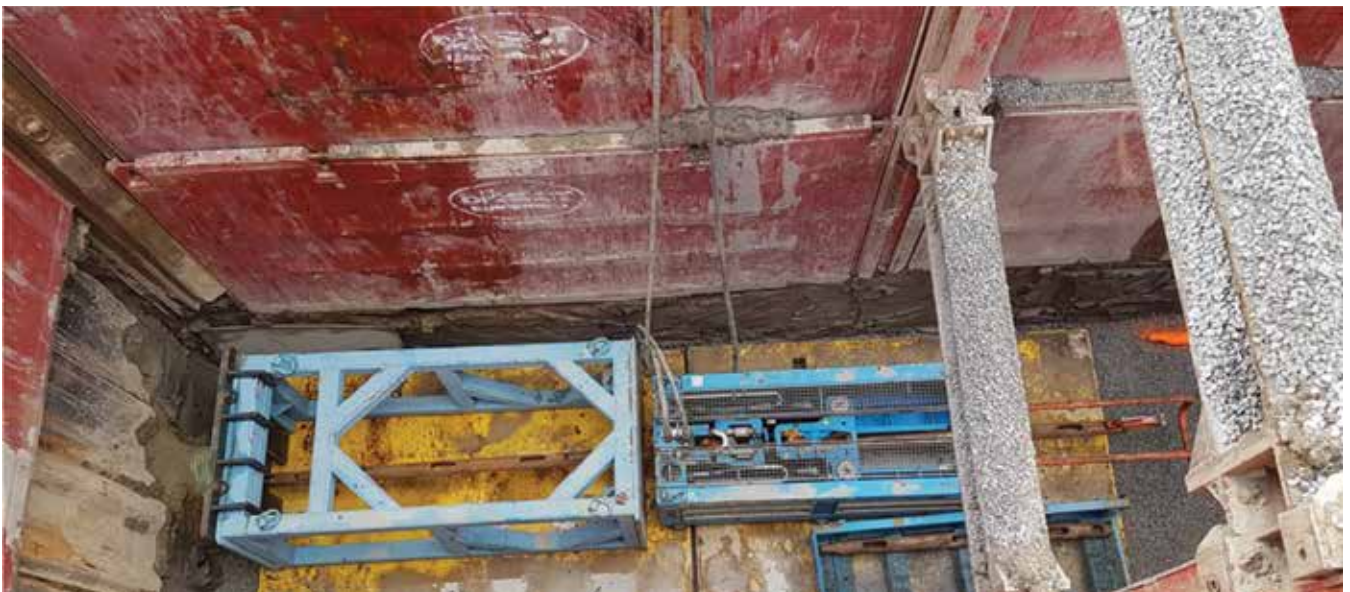
Figure 10. The static pipe bursting unit delivers 214 tons (427,137 bar) of pullback.

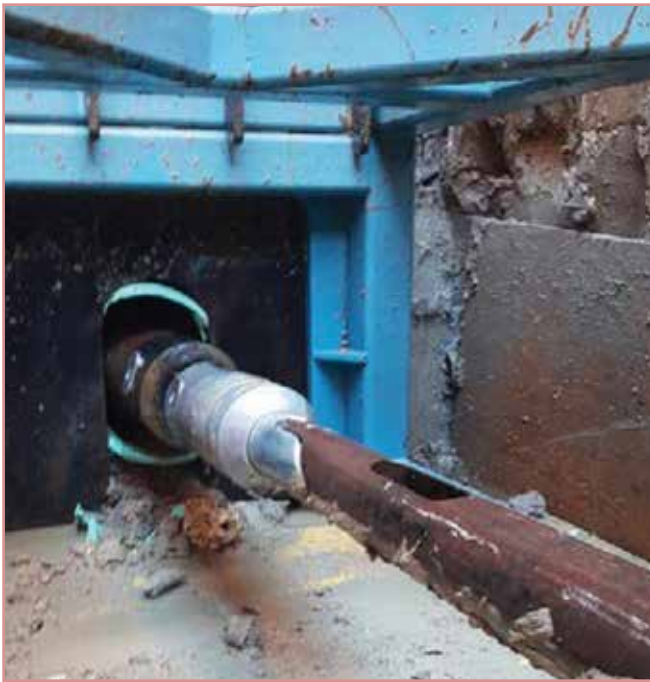
Figure 11. The low profile of the Quicklock bursting rods allowed Avertex to rod the existing PVC line, even though it had collapsed significantly.

section of pipe. Once through the collapsed section, the pullback force was lower for the remainder of the pullback, Figures 11, 12, and 13.

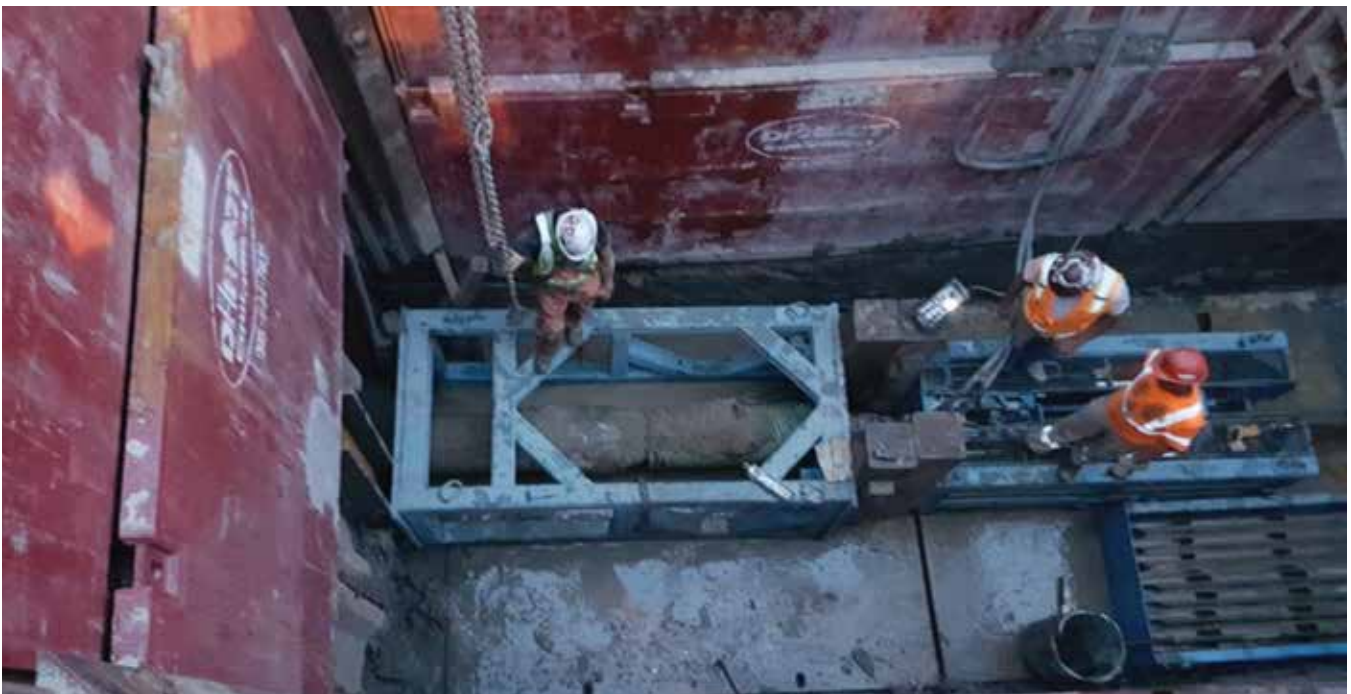
Figure 12. An extension frame on the pipe bursting unit provides the space between the wall of the shaft and the machine to facilitate the entry of the new pipe.

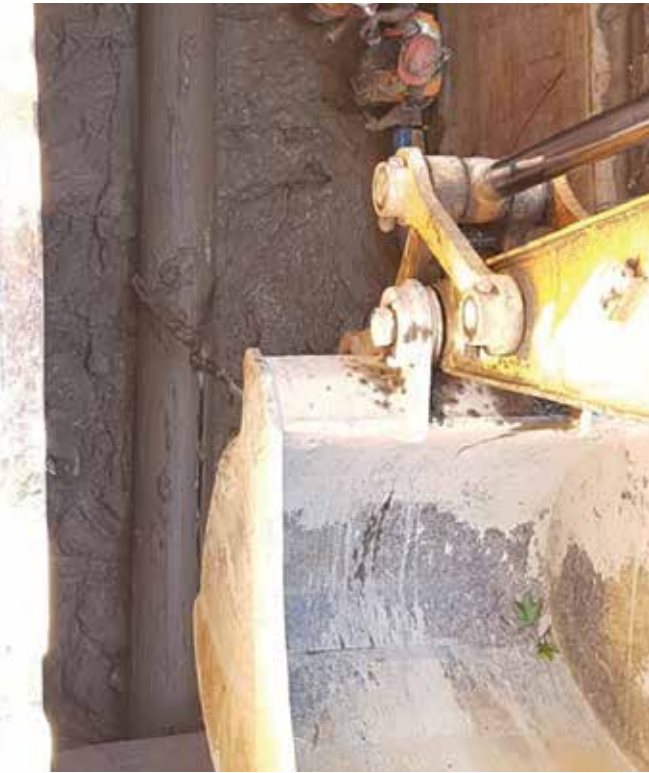
Figure 13. The new 230-foot (70 m), 18-inch (450 mm) diameter HDPE pipe successfully installed.

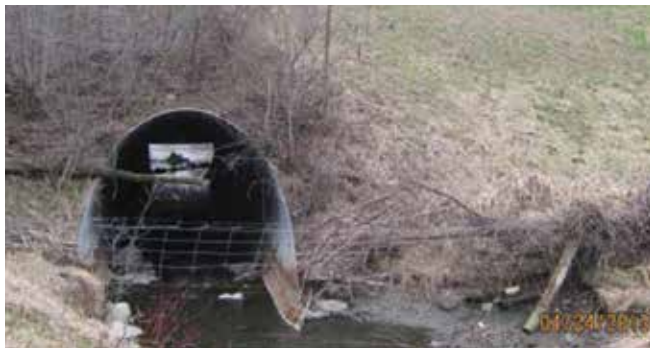
Figure 1. Upstream end of culvert, before construction.

The culvert was approximately 10 m deep and 65 m long. From the upstream end on the west side, the SPCSP section was about 34.5 m long and consisted of an elliptical shape with an approximate span and rise of 4,000 mm x 4,300 mm, respectively, with a 5 mm to 6 mm steel plate thickness. The inlet to the culvert extended beyond the embankments. Corrosion of the existing structure was concentrated at and below the water line.

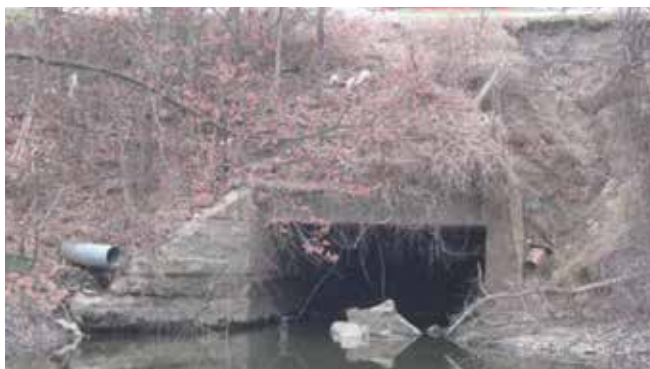
Figure 2. Downstream end of culvert, before construction.

The SPCSP section overlaid the top of the concrete culvert slab, but was overlapped by the concrete culvert sidewalls. Erosion and deterioration of the structure had caused collapse of the northeast wingwall and a slope failure in the east (downstream) embankment.

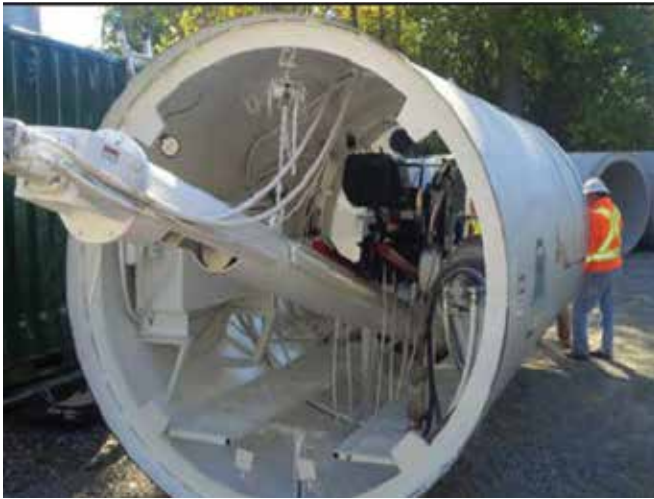
An intermediate jacking station (IJS) was installed to better distribute the jacking forces. To reduce external skin friction and reduce jacking pressures if necessary, bentonite slurry could be injected along each concrete pipe. As well as providing lubrication, the slurry would ensure that the modest overcut of the tunnel machine was completely filled, reducing the magnitude of surface settlement. Figure 3 shows the TDM brought to site.

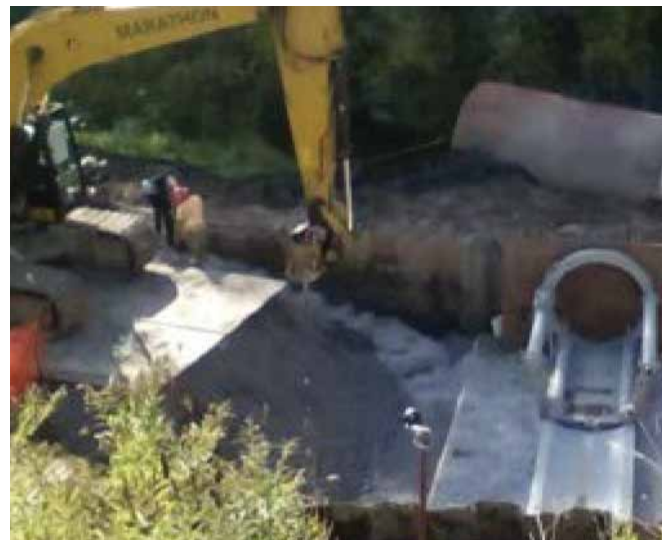
A steel sheet pile cofferdam was constructed to isolate the entrance pit from the surface water channel. Due to the restricted footprint available between the channel and the tunnel face, a localized stream diversion was required to allow for the construction of the 7 m long, 5 m wide pit. This was accomplished using sections of 3 m diameter steel pipes, through which the channel flowed around the excavation and, ultimately, through the existing culvert that was still in operation. This gravity by-pass was left in place for the entire duration of the tunnelling operation. It was an important component of the overall approach to construction staging that was envisaged during the design period and one that contributed to the selection of the overall approach to renewing the structure: a new culvert by tunnelling, and a rehabilitated culvert by sliplining. Figure 4 shows the entrance pit and re-aligned channel on the west (upstream) side.

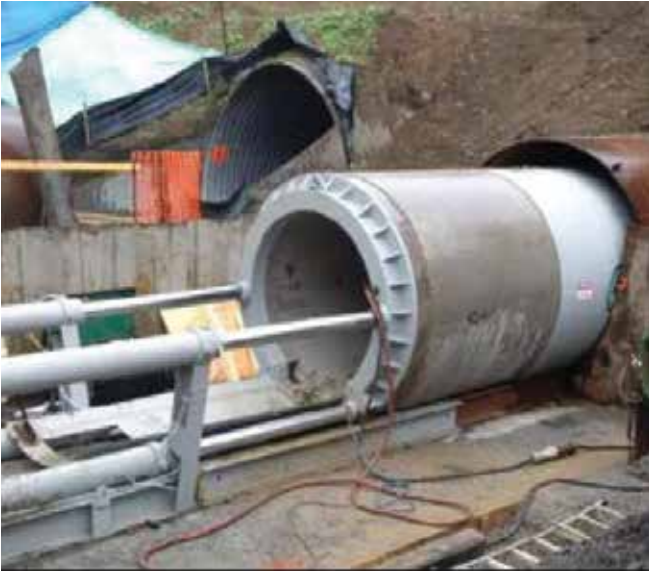
The backstop design consisted of steel plates supported by four vertical piles (acting in tension) and eight diagonal piles (acting in compression), driven through the earth and socketed a minimum of 4 m into the bedrock, for a factored jacking force of 600 tonnes. The jacking station was welded to steel rails set in a concrete mud slab, with a granular pad underneath. The working slab was attached to the backstop with steel pipes and beams, welded to the vertical and diagonal piles, to counter the horizontal jacking forces. Prior to tunnelling, a short section of 3 m diameter steel pipe was installed by open cut into the embankment face to act as a tunnel portal. Figure 5 shows the TDM and the first pipe section being jacked into place, with the existing culvert and stream diversion in the background.

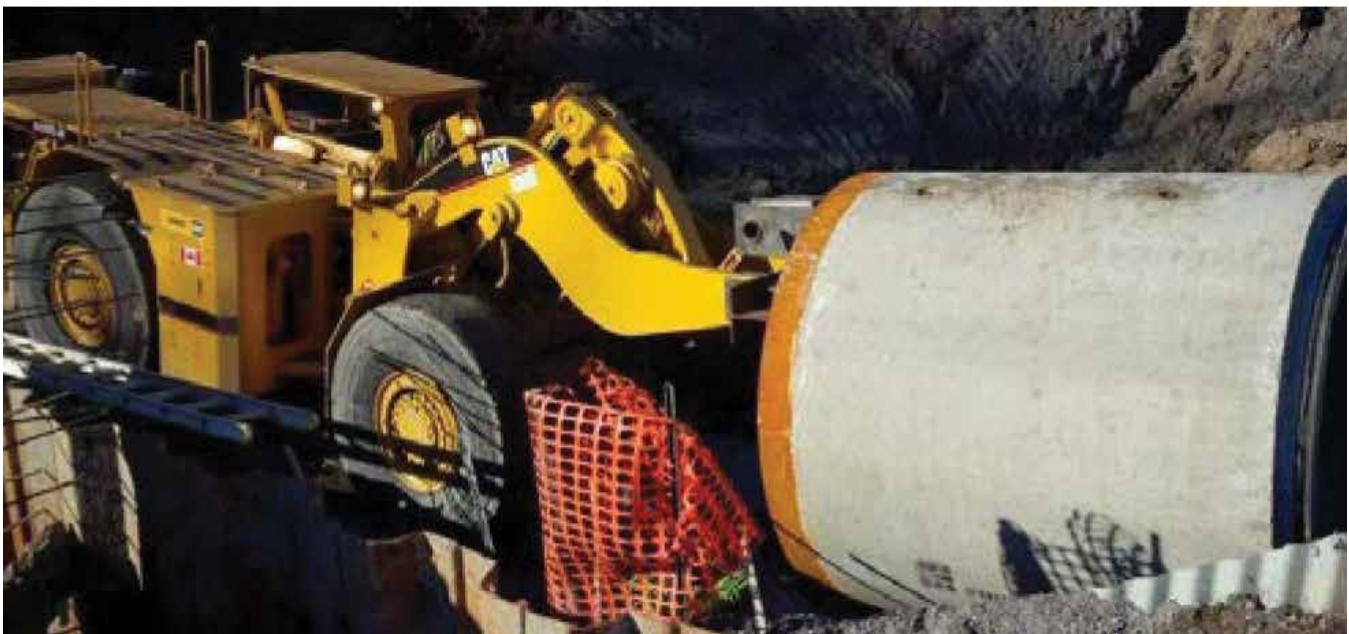
Figure 6

The open cut excavation on the east side was successful in exposing the front face of the TDM. During the course of this excavation, large pieces of the concrete abutment, that had ultimately stopped the tunnelling operation, were also removed. Considerable difficulty was experienced pushing the custom pipe sections into the "can," as the steel housing had "squeezed" such that the casing was no longer perfectly round. Ultimately, the pipes had to be into place from the shored excavation on the east side. Once the "can" was lined, the remaining sections of concrete culvert pipe were placed in open cut without incident.

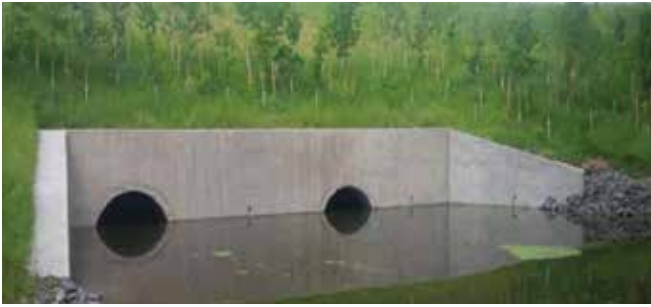
Figure 7. Upstream end of culvert, after construction.

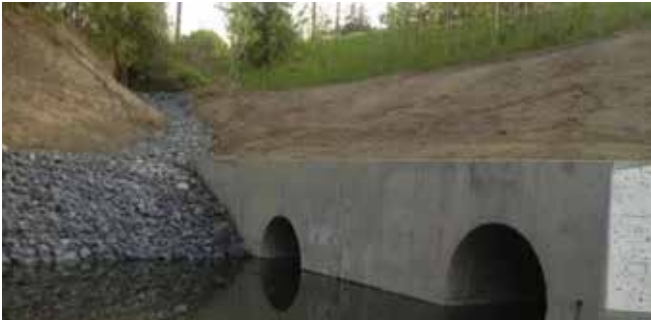
Figure 8. Downstream end of culvert, after construction.
