# **NORTHEAST JOURNAL**

OF TRENCHLESS TECHNOLOGY PRACTICES

***“Celebrating Trenchless”***  
***4th Annual Northeast Regional Chapter***  
***Trenchless Technology Conference***  
***Syracuse, New York***

**2019 FALL EDITION**

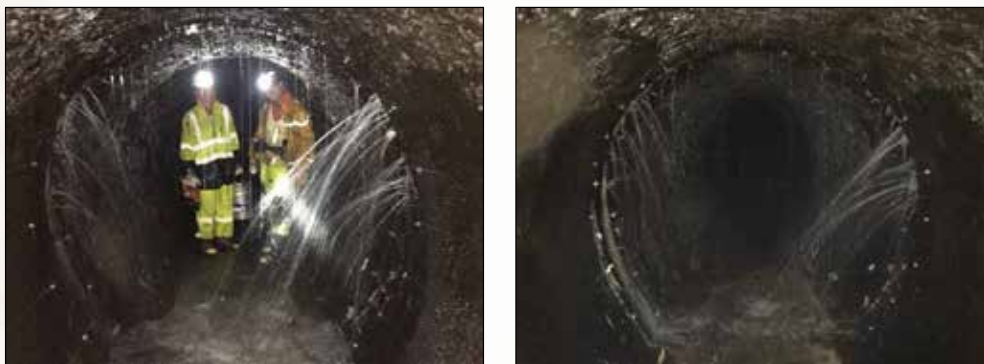
Figure 3. Before and after chemical grouting on the left arch.

Another recommendation resulting from the initial inspection was for the heavy seepage at the construction joints in the first 71 feet of the tunnel to be injected with chemical grout. At each joint, the injections were supposed to chase the seepage around the joint and then seal them off. This was attempted with limited success and was not considered critical for the operation of the tunnel (Figure 3). Because this was not deemed critical to the continued operation of the tunnel, no other methods for sealing the joints were considered.

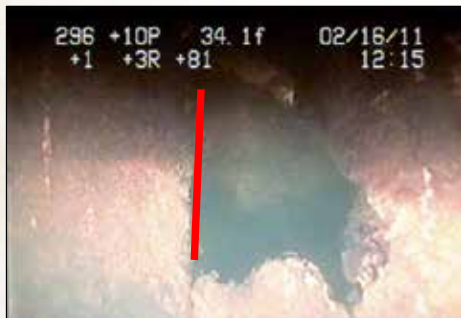
(a) Defect during 2011 ROV Inspection (SeaView, 2011).

Figure 4. Views of defect at transition to pipeline at Sta. 29+61 from various inspections. Note that the red line is in approximately the same location in each image.

What was of concern to the inspection team was the apparent increase in the size of the defect at the transition point at approximately Sta. 29+61. The defect now measured 24 inches radially by 36 inches longitudinally in the liner with a large cavity behind it, measuring at least 23 inches deep by 39 inches wide (MJA, 2017). There was also concrete debris in the invert that was not previously seen in 2011. While exfiltration was observed, the inspection team was unable to quantify the exfiltration at this location. In addition to optical cameras, side scanning sonar was used to map the extent of the defect. This inspection was able to continue through the 48-inch pipeline to the gatehouse.

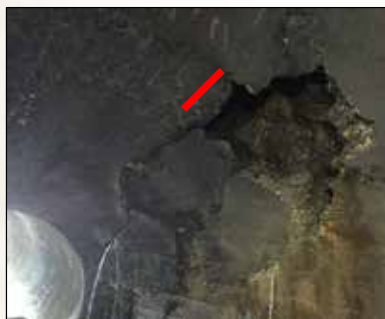
(c) Defect after dewatering and minor scaling for safety.

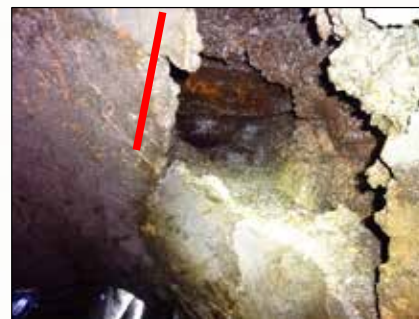
(d) Looking into void (downstream), approximately 10 feet deep.

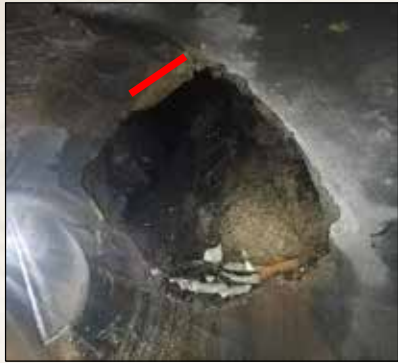
(e) Defect after sawcutting and chipping in preparation for repair.

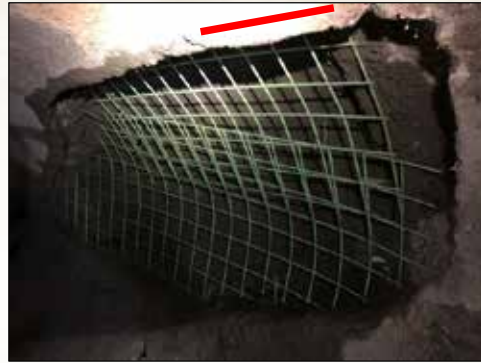
(f) Welded wire mesh in place during shotcrete repair.

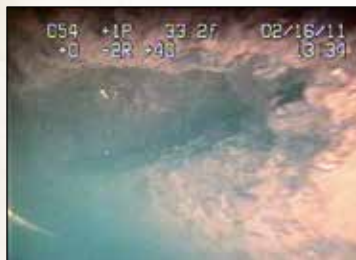
(a) Defect during 2011 ROV Inspection (SeaView, 2011).

Figure 5. Views of defect in crown at Sta. 23+15 from various inspections.

concrete lining of the tunnel directly, and any attempt to find these smooth, healed cracks would have taken significant effort and time, with little benefit. The previously identified crown defect at approximately Sta. 23+15 was found to have changed little, and it again appeared that no water was exfiltrating the tunnel at this location. This defect was again classified as a narrow and fully penetrating structural feature defect because it locally interrupted the concrete lining but did not appear to have a cavity behind the lining nor was it considered to affect operational reliability at the time.

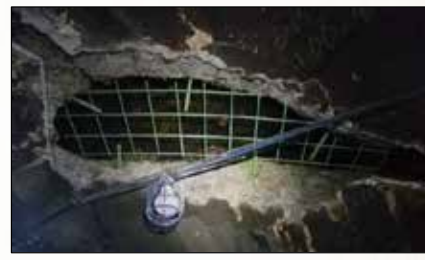
(c) Welded wire mesh in place for shotcrete repair.

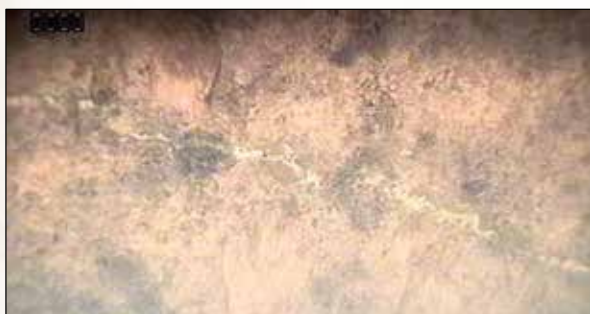
Finally, Figure 6 shows images from the 2011 ROV inspection and the manned inspection of a surficial crack at Sta. 6+90. With good visibility, the defect was fully visualized with the ROV. However, during the 2017 planned ROV inspection, the defect could not be found because of the poor visibility.

(a) Defect during 2011 ROV Inspection (SeaView, 2011).

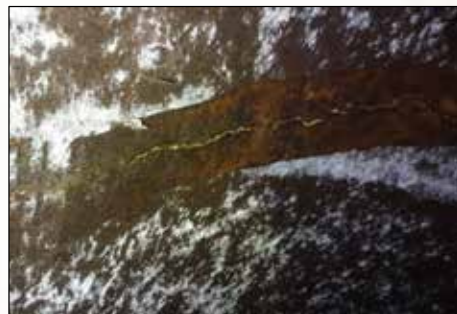
(b) Defect after dewatering.

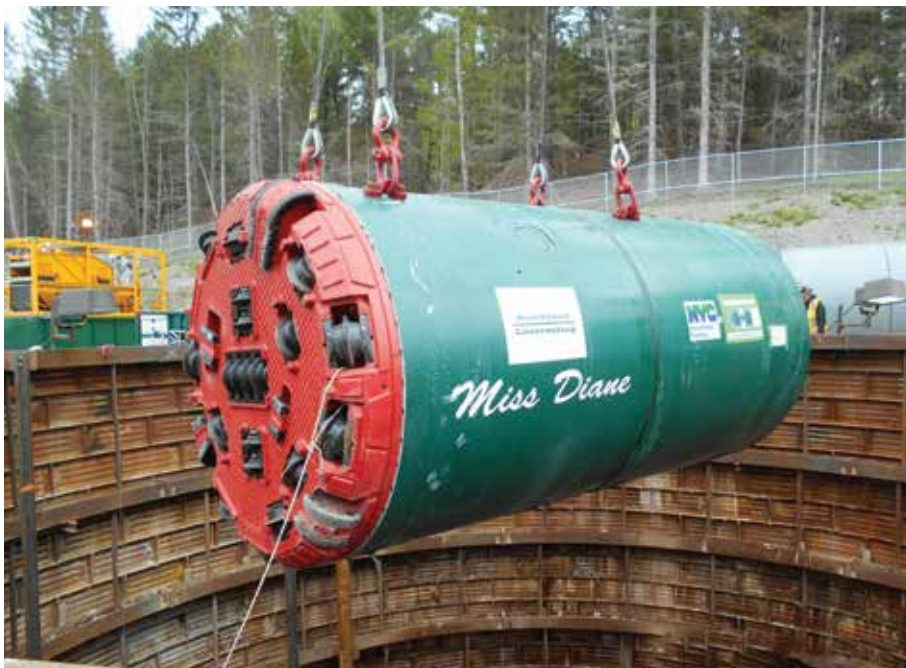
Figure 1: The Herrenknecht AVN2200B MTBM “Miss Diane” lowered to the land leg tunnel launching site. The first of its kind manufactured in accordance with OSHA Class I Division II classification

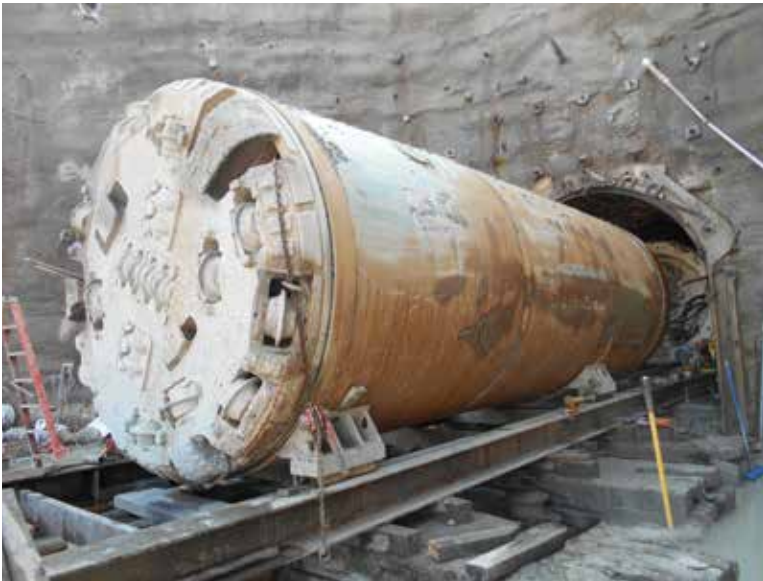
Figure 3: MTBM pushed through Valve Chamber portal to complete the land leg tunnel

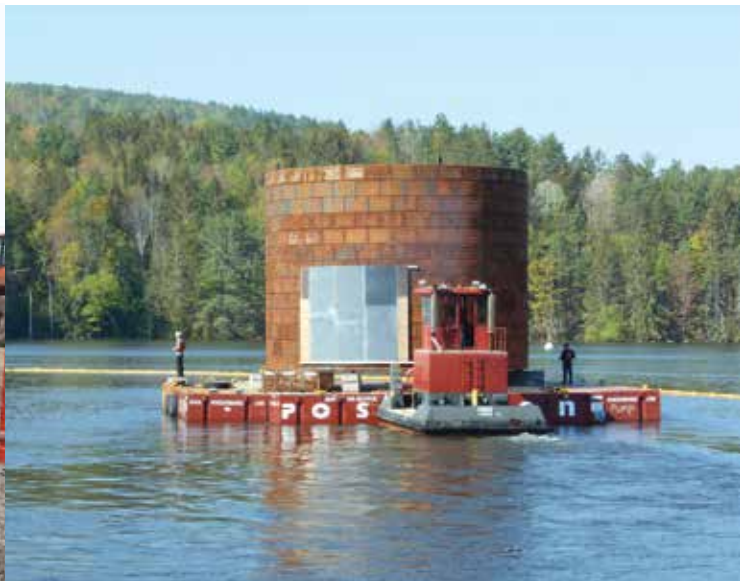
Figure 5: Water leg cofferdam structure with fiberglass soft eye

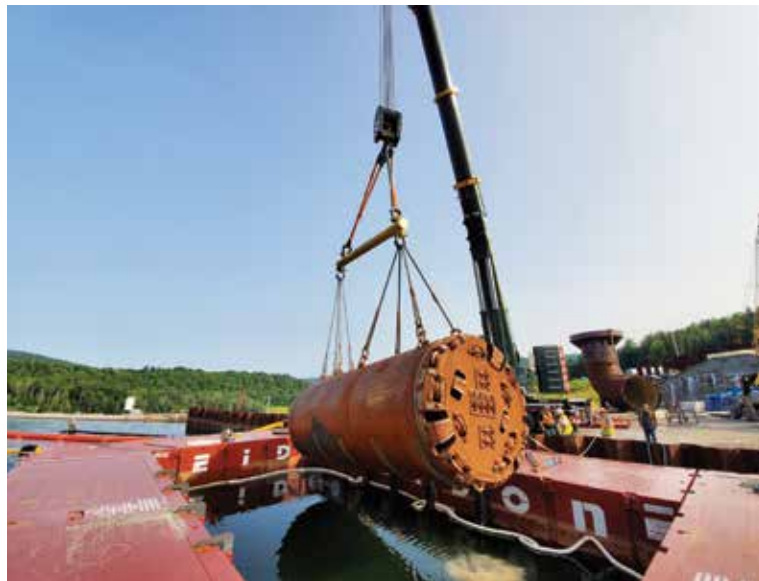
Figure 6: The MTBM unit was retrieved from a depth of approximately 153 feet on July 10, 2019

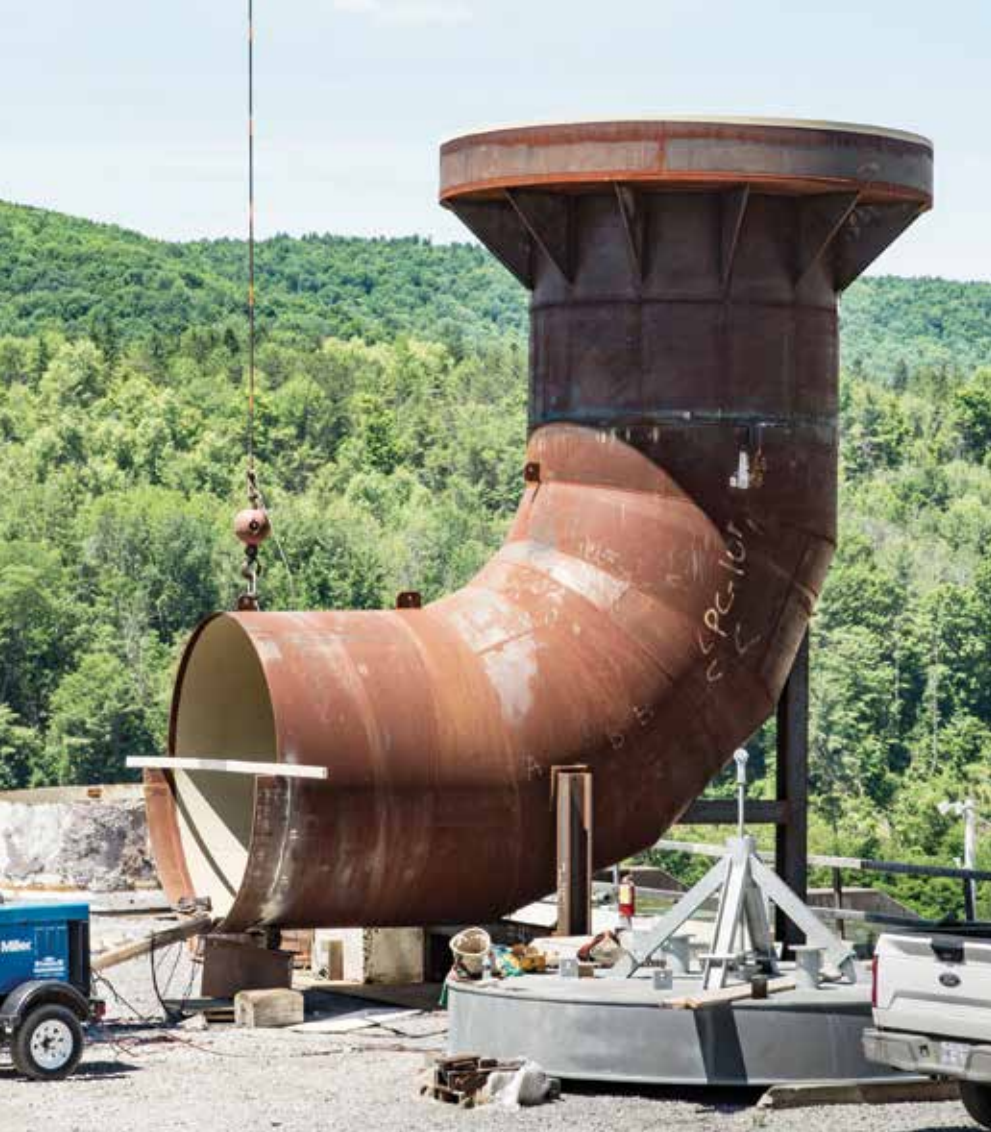
Figure 7: 108-inch elbow for the intake. In foreground is removable plug/bulkhead used for dewatering water leg tunnel

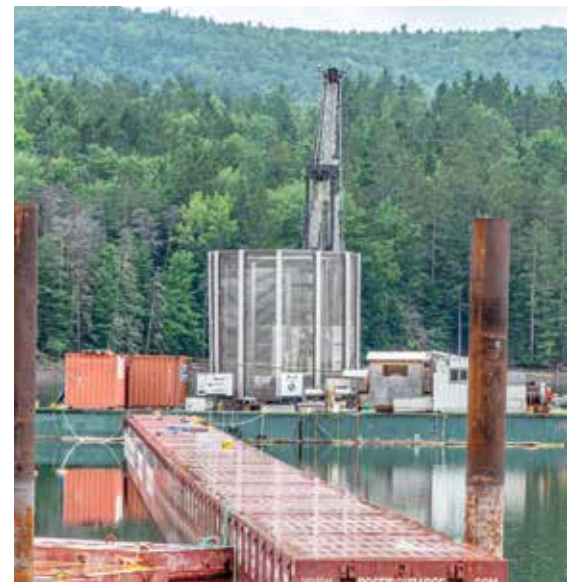
Figure 9: The stainless steel Intake Structure was lowered into place and tremie concreted

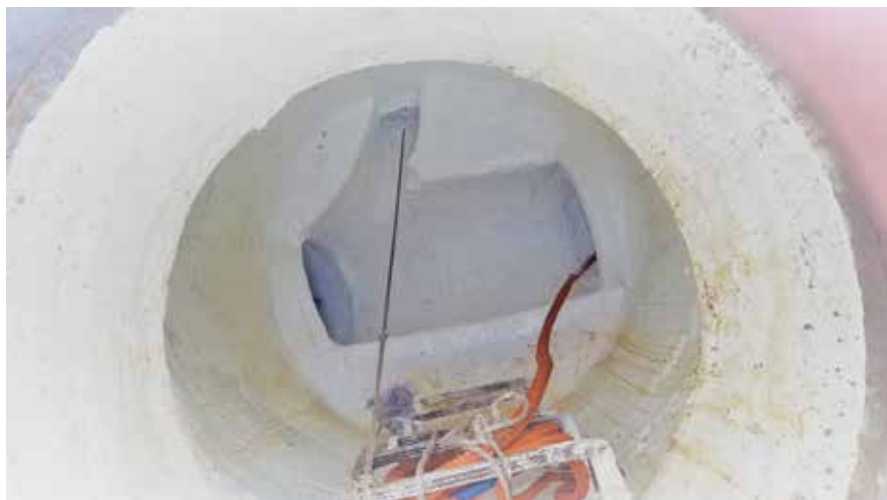
*The 39 manholes along the 1.8 mile segment were coated with an aquatic-safe epoxy*

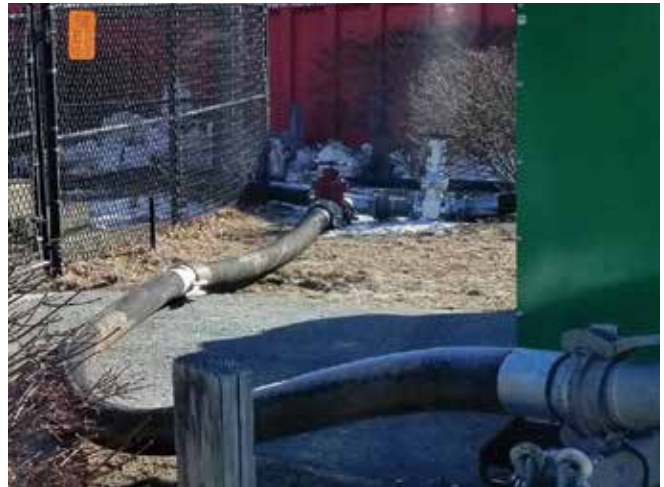
Bypass setup pumped over 110,000 gallons average daily flow

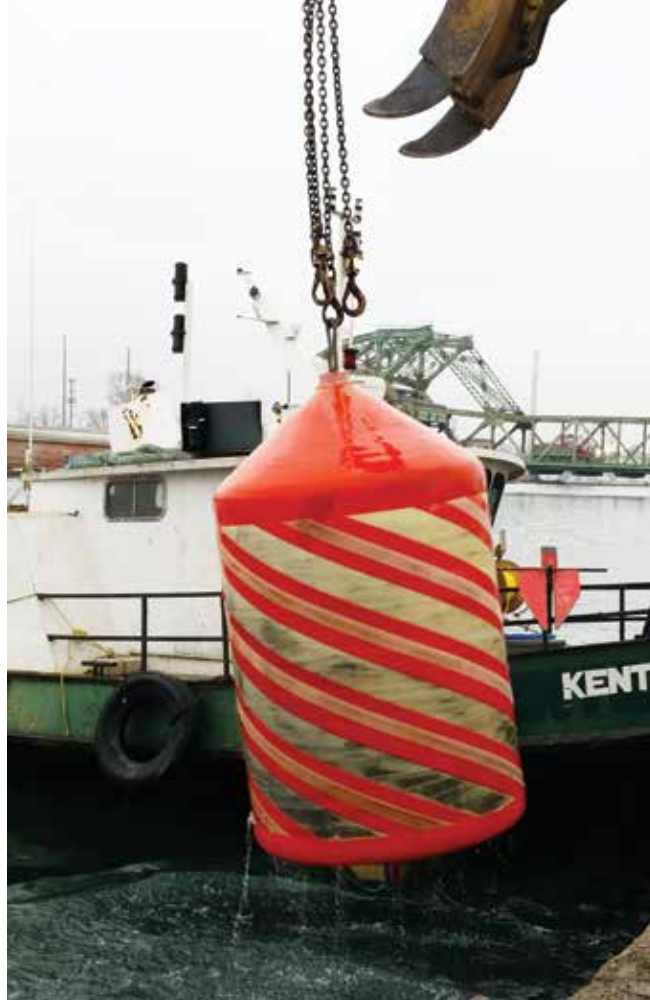
Figure 6.60-inch brush pig after being towed to shore

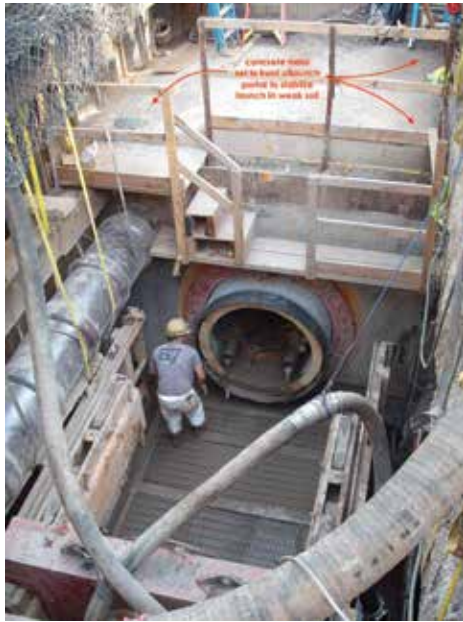
Figure 3- Photograph of MTBM launching shaft depicting the use of concrete mass ground stabilization in front of launch portal to stabilize weak soils.

In response to these ground effects and challenges, one specialty contractor opted to install a large mass of low strength concrete in front of the jacking shaft launch portal to stabilize the launch of the 48-inch MTBM out from the shaft and into the soft ground ahead of the drive (see Figure 3).

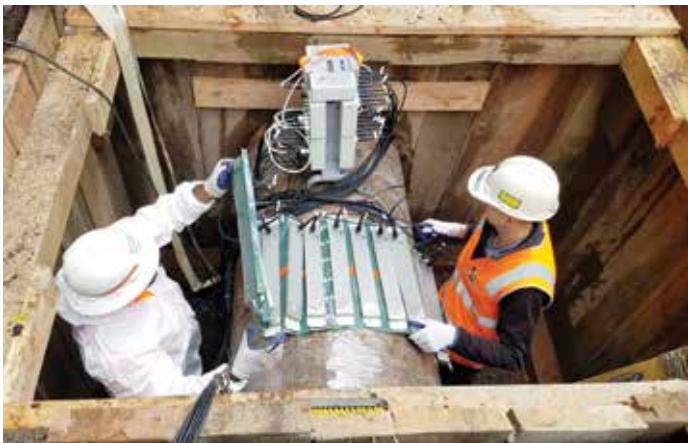
External NDT inspection of exposed CI pipe

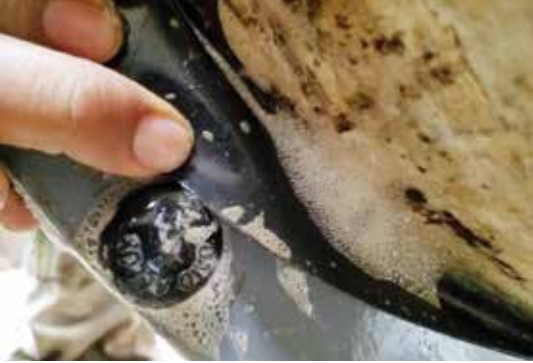
Leak at CI coupling

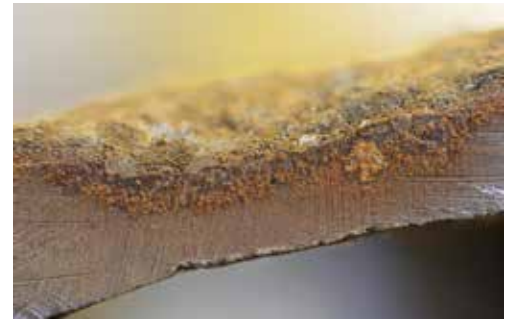
Graphitization cross section
