Pacific Northwest urenchless Review Forward With Trenchless Technology

Restoring Water System Confidence HDD Intersect Installation in Alaska Construction Data Collection

Restoring Water System Confidence with CIPP By: Brendan O'Sullivan, PE, Consor

Construction Data Collection on an 1160-foot Crossing of the Lake Washington Ship Canal with HDD

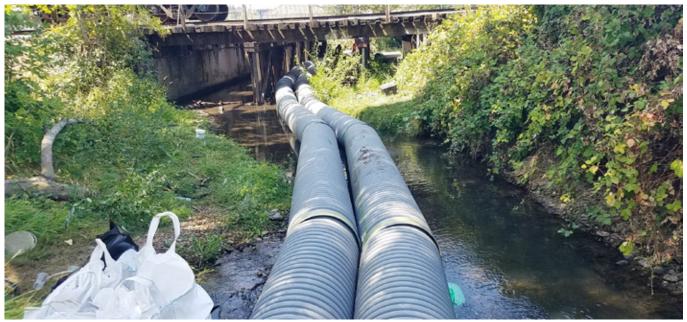
Bypass Piping

connections between the existing welded steel and the new ductile iron piping, custom fabricated reducing couplings, with electrically isolating boots manufactured specific to the outside diameters of the project pipes, were specified. The CIPP liner would line through the pipe material transition and terminate in the new ductile iron pipe and internal mechanical joint style seals would be used for the ends-seals. With new DI pipe at the connections, there is a potential for exfiltration of chlorinated water into the creek in the near term by way of cracks in the mortar lining of the pipe. These cracks are typically sealed/ closed through the autogenous healing process which begins once the lining is completely saturated. This process can take weeks to months to occur. To mitigate this short term risk of exfiltration, without sacrificing pipe longevity, the mortar lining material was removed from the DI pipe at the termination of the CIPP liner and the end seals will be connected directly to the barrel of the DI pipe with exposed metal surfaces first being prepared and coated with an NSF-61 approved epoxy product to protected against corrosion.

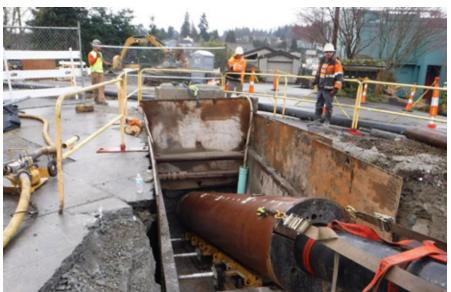
Figure 1: 20-foot section of 42-inch steel casing setup on guide rails and 20-inch pneumatic hammer

The pilot bore was drilled with a Universal 250x400 drilling rig with 250,000 pounds of pull and thrust capacity, using 5-inch outer diameter steel drill

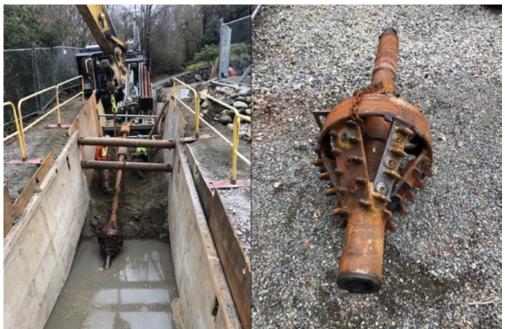
Figure 3: (Left) Ream Pass 1: 24-inch reamer installed on drill string and (Right) 24-inch Short Barrel Fly Cutter

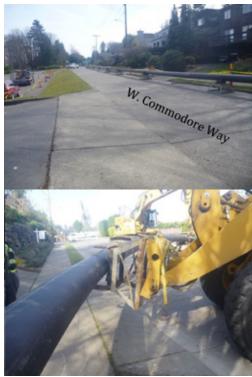
Figure 4: (Left) 16-inch HDPE pipe staged in roadway and (Right) Use of loader to manage pipe layout during pullback

The contractor installed the 16-inch HDPE pipe in one shift. The pullback was completed with one mid-pull fusion weld. The entire 1200 foot pipeline was not fused prior to pullback because the 1200 feet of laydown space required would have caused loss of access to many residents along W. Commodore Way (Figure 4).
