# Pacific Northwest Trenchless Review

## 2024/2025

**Pacific Northwest Trenchless Symposium 2025  
Bull Run Filtration Facility Microtunneling Site Tour  
February 11 - 12, 2025 Portland OR**

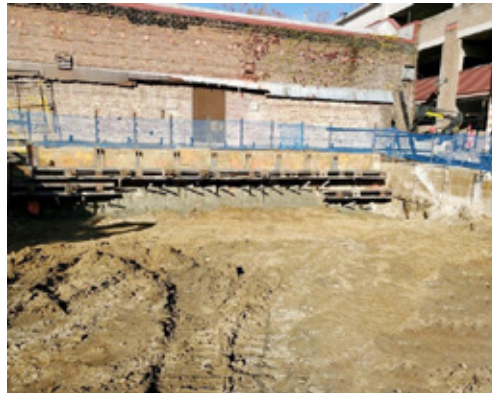
Figure 1: The Bressi Building, a historic structure requiring preservation during the Climate Pledge Arena construction

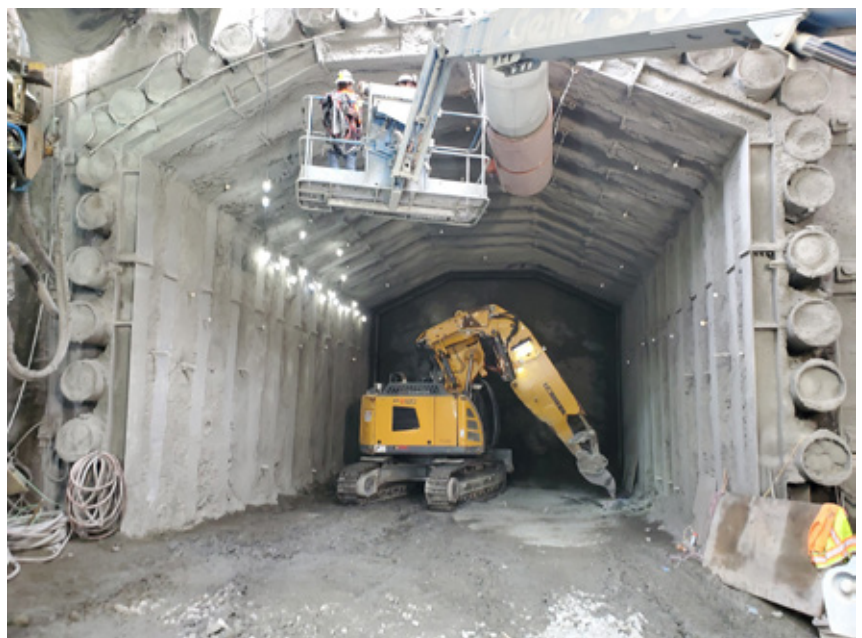
Figure 6: SEM Construction

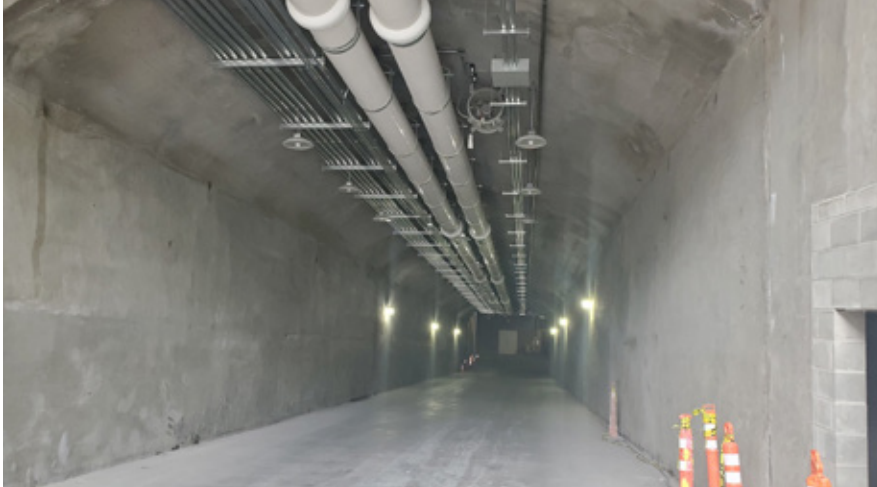
Figure 7: Completed Climate Pledge Arena Tunnel

completed project is shown in *Figure 7*. The project met its schedule and budget goals, delivering a state-of-the-art facility

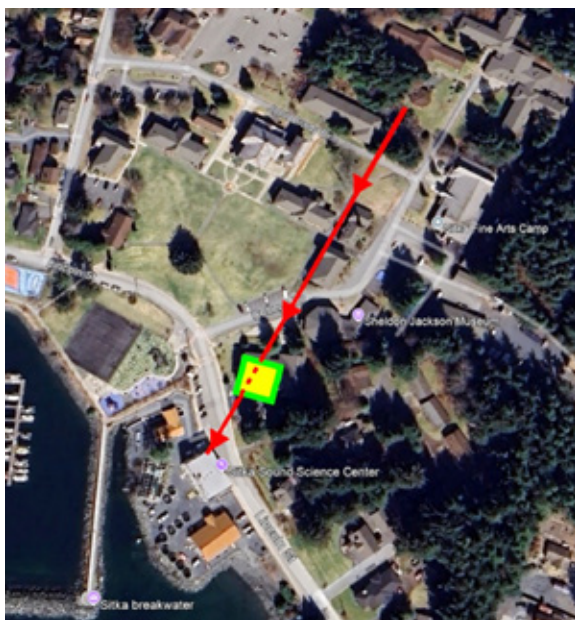
Figure 1. Project Alignment with Flow Direction, Green Box Indicates Library Footprint

As shown in Figure 1, the penstock pipe conveys freshwater from the Indian River flume to the hatchery building, approximately 800 feet from the flume. The existing penstock pipe is routed under the library, increasing the risk of damage to the building if the penstock pipe failed before rehabilitation could be completed. The SSSC contacted Coffman Engineers (Coffman) in 2022 to provide recommendations and design to rehabilitate the existing penstock.

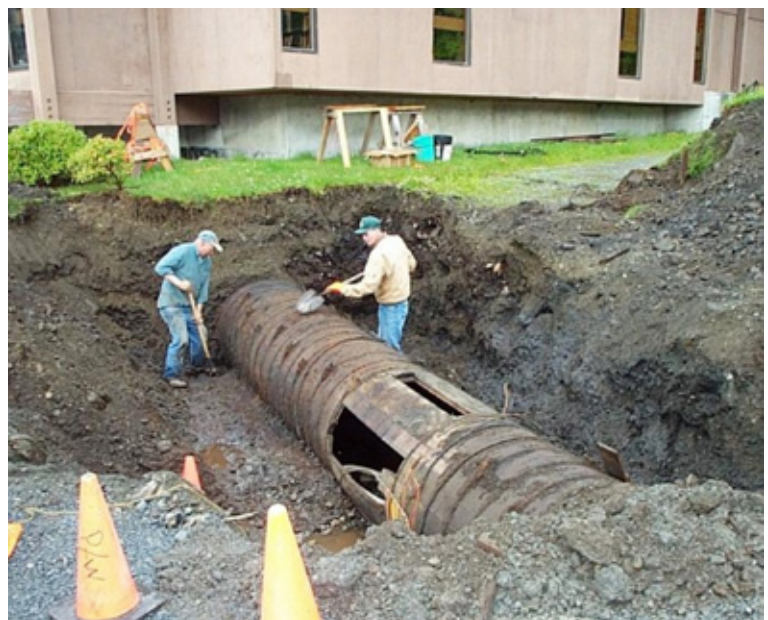
Figure 2. Exposing the Damaged Penstock Pipe in 2001, Note Library Proximity in the Background

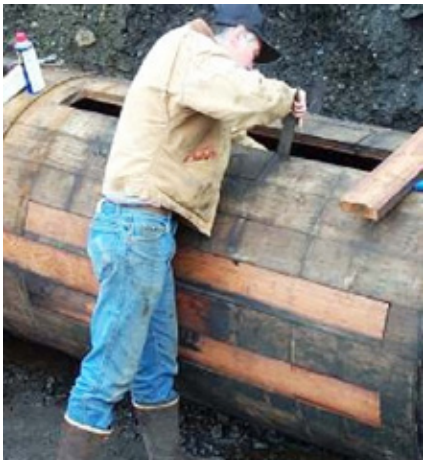
Figure 3. Historical Penstock Repair

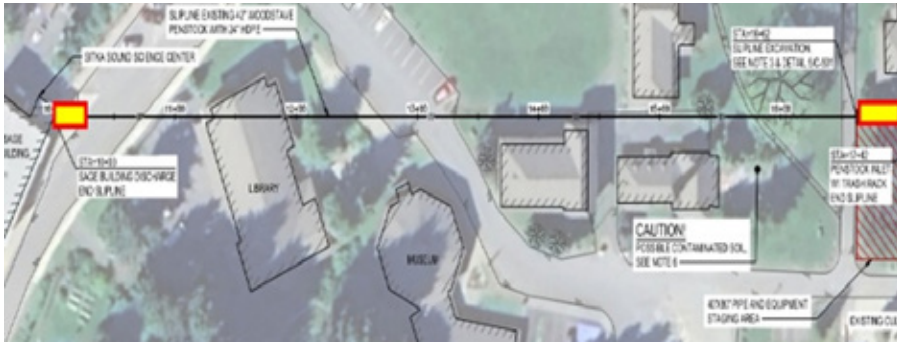
Figure 4. Slipline Access Pit Locations

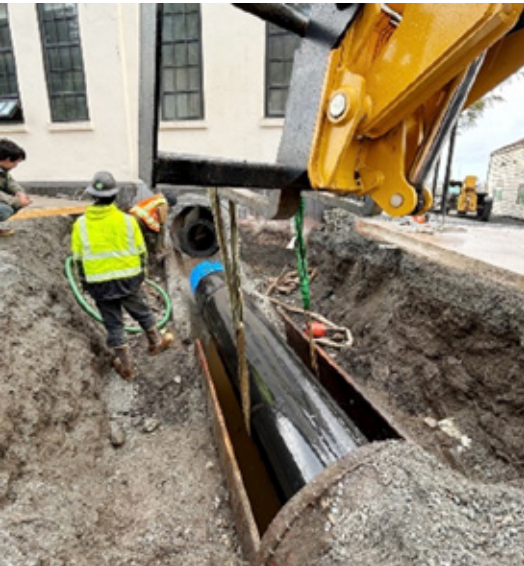
Figure 6. Slipline Access Pit Near SSSC Hatchery

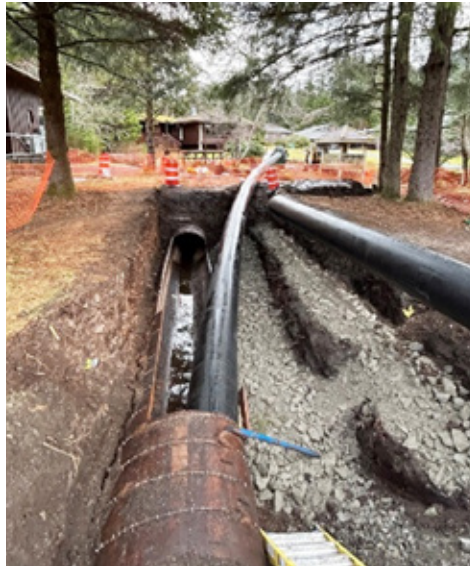
Figure 7. Slipline Access Pit Near Penstock Inlet Near Penstock Inlet air

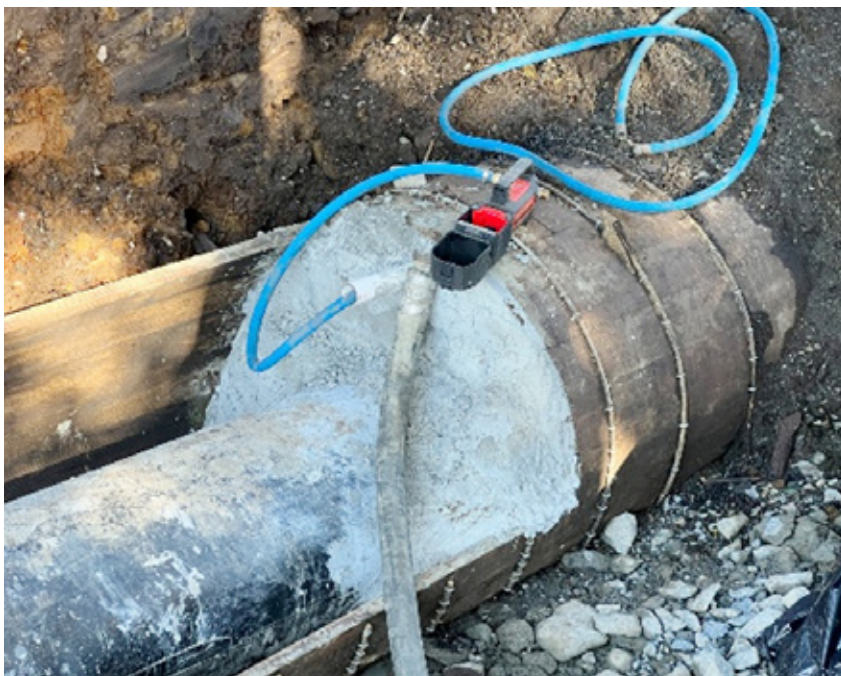
Figure 8. Bulkhead Construction

a week. The contractor then spent a week building bulkheads for the annular space grouting.

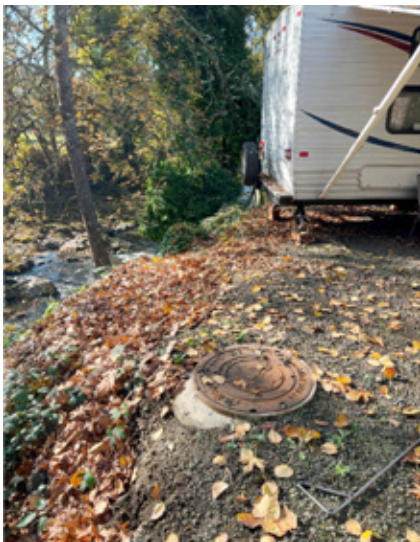
Figure 1. Manhole Along Deer Creek Trunk, Adjacent to Steep Slope

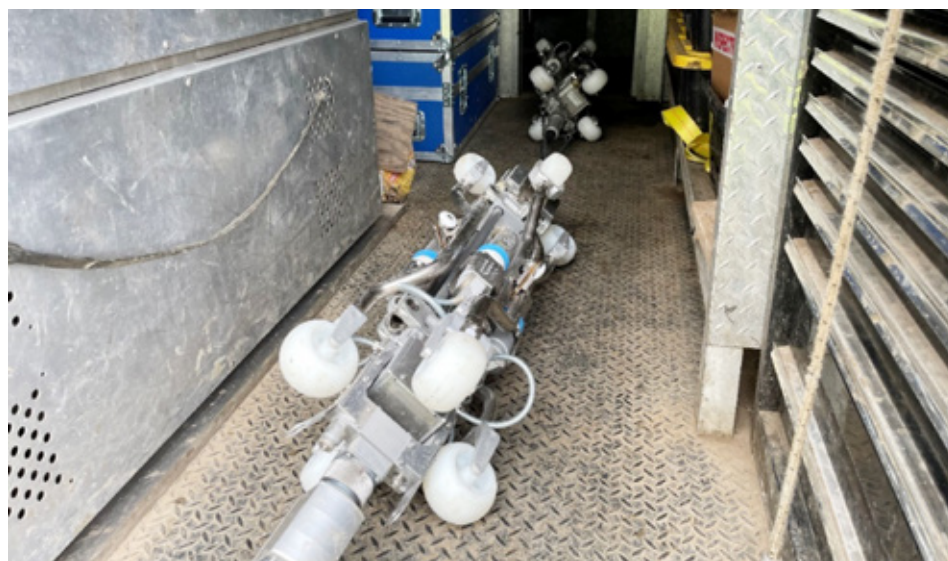
Figure 4. UV Light Train

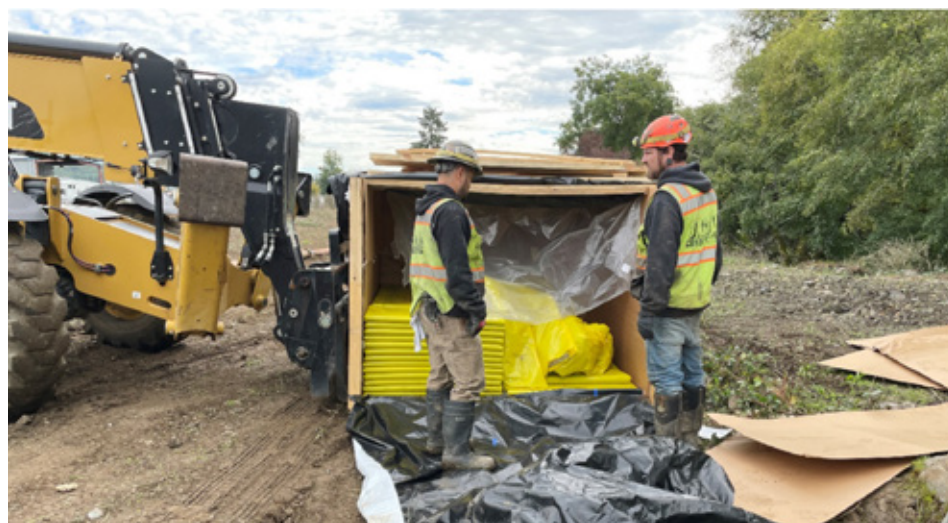
Figure 5. Staged UV-CIPP liner

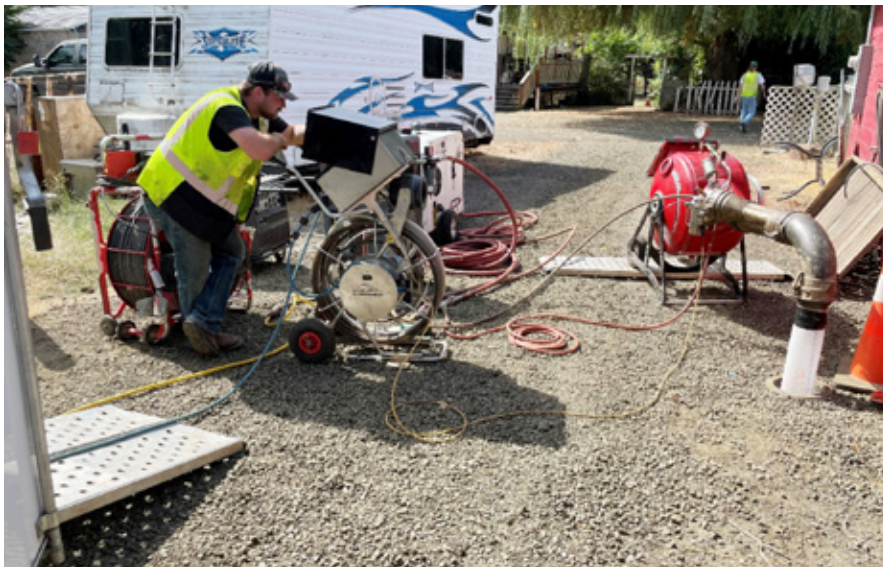
Figure 6. LED lateral lining through existing cleanout

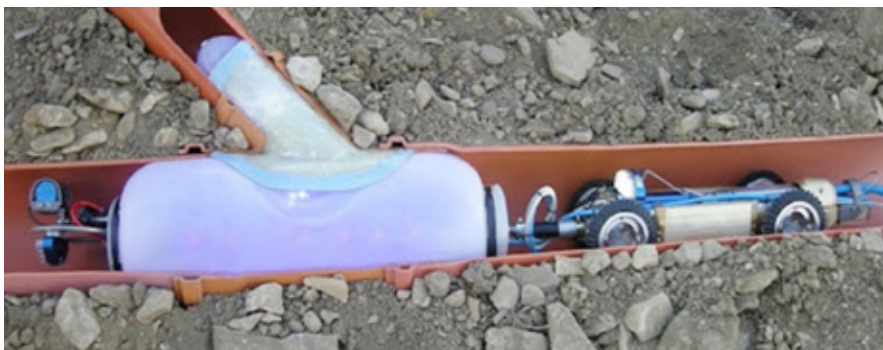
Figure 7. Cosmic Tophat Lateral Connection Liner

A brim-style lateral connection CIPP product was used for all rehabilitated laterals to provide a watertight connection between the newly rehabilitated mainline and laterals and prevent infiltration from entering RUSA's sanitary sewer collection system. For this lateral mainline connection liner, Oxbow selected the Cosmic Tophat Lateral Connection System, as shown in Figure 7.

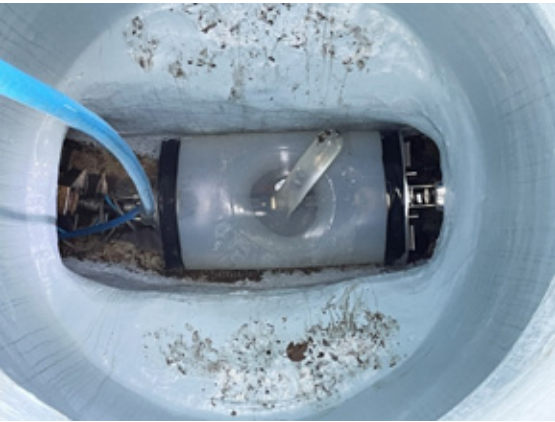
Figure 8. Lateral Mainline Application Device

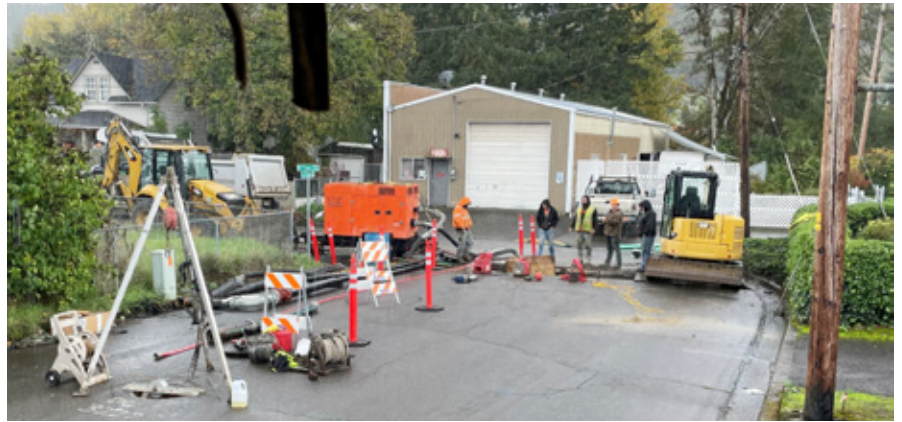
Figure 9. Sanitary Sewer Bypass Piping Entering Stormwater System

The design team provided a conceptual bypass plan in the Bid Documents which showed the latter option of routing through the storm system, with the bypass piping entering a storm manhole on the south side of NE Diamond Lake Blvd. and exiting the system via a manhole north of the road. Ultimately it was up to the

Because the sanitary sewer piping ran through a storm system which discharges into Deer Creek, several precautions were taken to avoid raw sewage entering the creek. The storm system was plugged downstream of the bypass piping so that if a leak did occur, no sewage would reach an outfall. Additionally, a monitoring and spill response plan was submitted to the City for approval prior to construction.

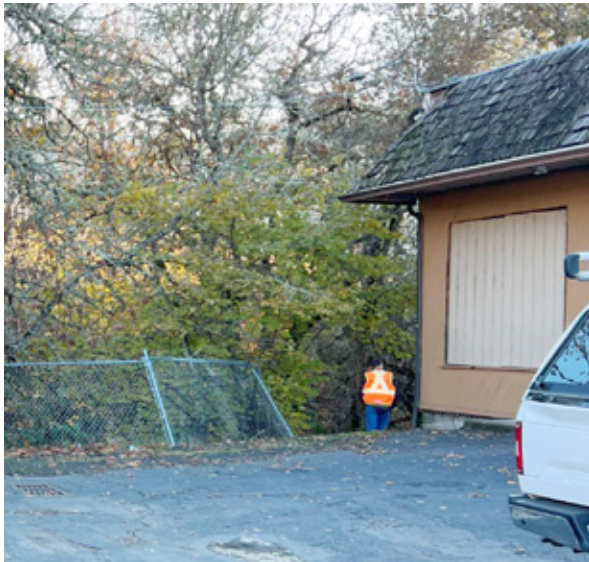
Figure 10. Location of Building Covering Deer Creek Trunk Manhole

To rehabilitate the trunk line without digging at this location, the contractor ended up coordinating with the private property owner to gain access. The contractor paid the property owner a fee to uncover the manhole and install a locking, watertight manhole cover within the building that can be used by RUSA in the future. Since the manhole is inside a building, it will still require coordination with the property owner for future access, but RUSA now has the option for any needed maintenance or repairs.

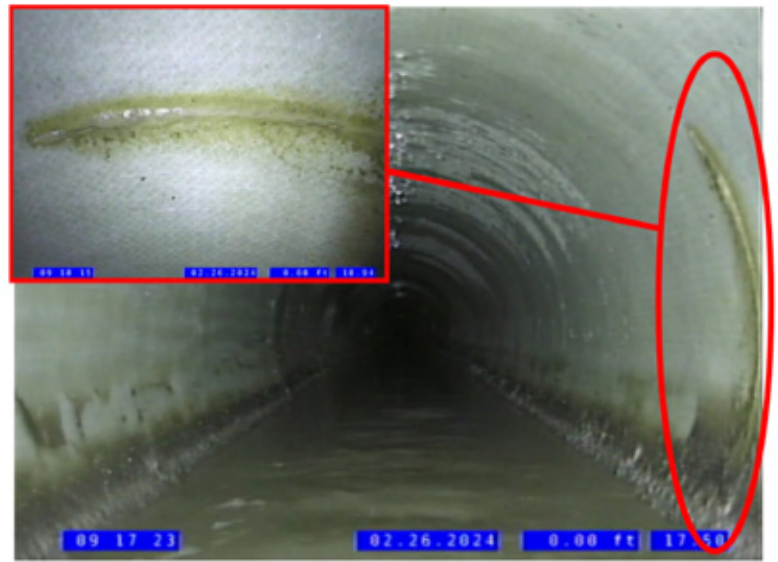
Figure 11. CCTV Inspection Footage of Pinholes in Cured Liner

It was discovered that the provided liner had pinpoints which did not cure properly, causing uncured resin to leak out of these

points. In order to determine whether these defects structurally compromised the cured liner, the contractor was required to send a sample of the defective liner to a third-party testing company. Testing confirmed that the cured liner met the structural specifications of the Bid Documents and that the defects were non-structural in nature. In addition to these test results, an extended 3-year warranty was provided by the contractor and manufacturer in order to protect RUSA in case of deterioration of the defects.

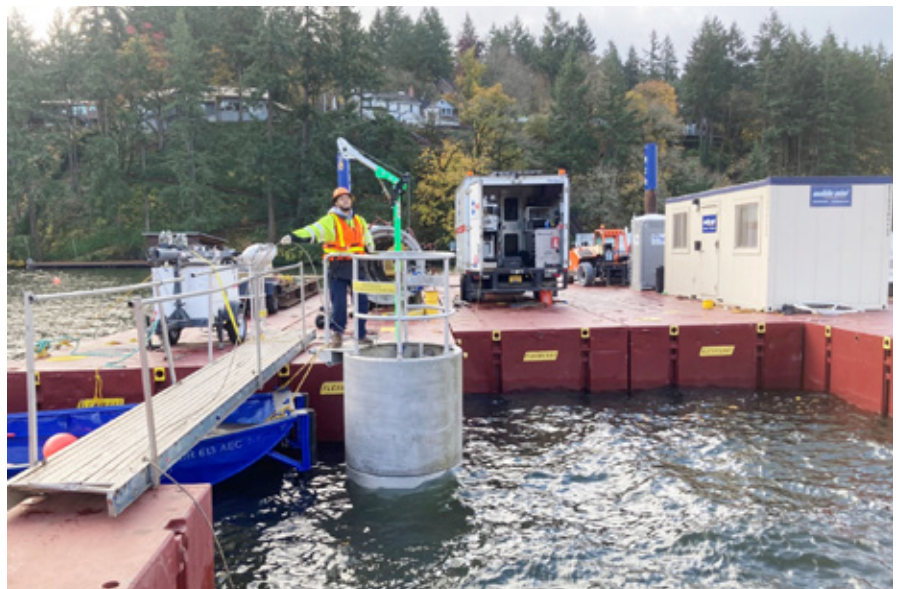
*On water inspections were completed in 12 weeks*

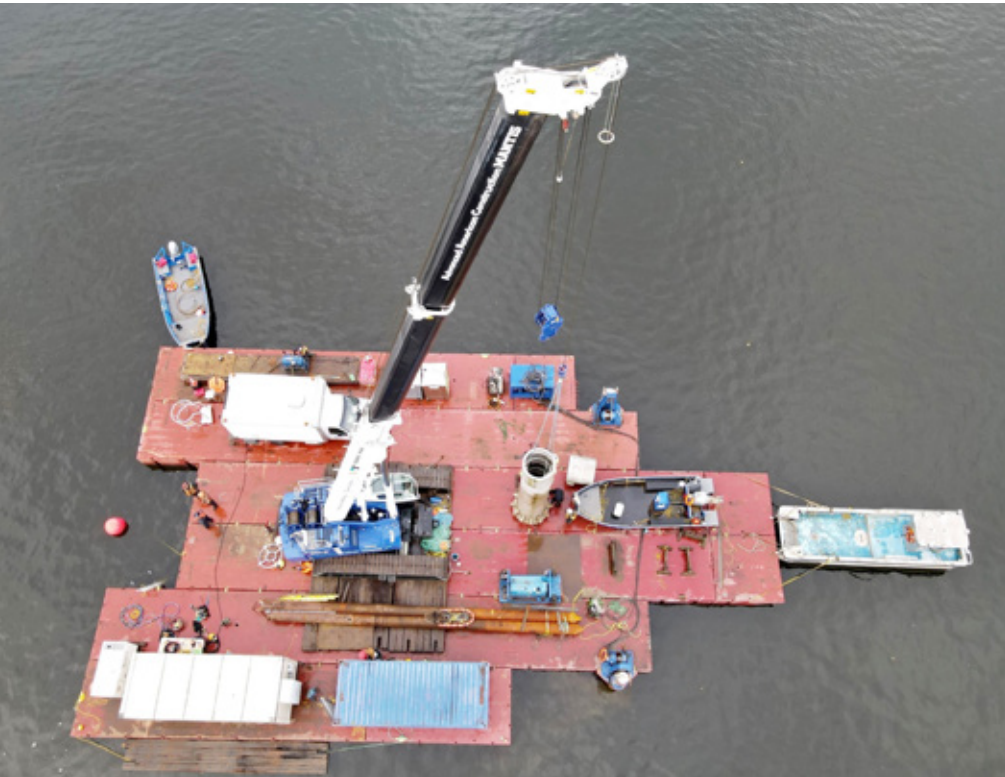
Barge Alpha – the team relied on two barges for inspection

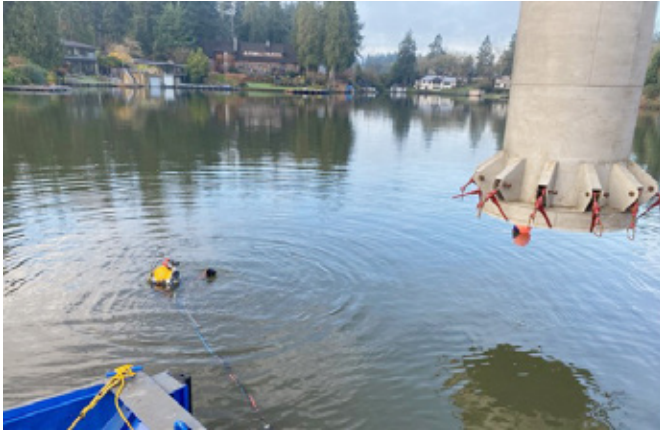
Caissons were installed and dewatered to facilitate access to the sewer

stainless steel caissons on adjacent submerged manholes to facilitate access into the sewer. Working from west to east across the lake, caissons were installed and dewatered, providing the inspection team access into the sewer for the deployment of crawlers and/or multi-sensor platforms (depending on the flow levels) to collect video/imaging data of the pipe interior.

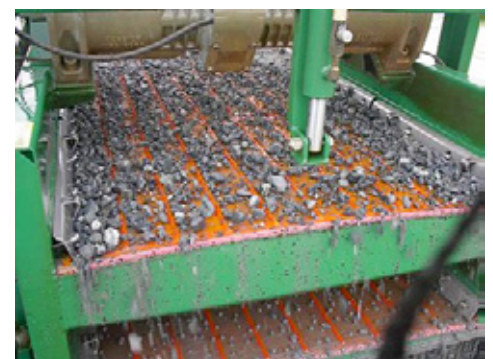
Figure 1 Coarse Screen on Microtunneling Slurry Separation Plant

When the slurry containing the excavated material is pumped to the ground surface, it typically passes through a slurry separation plant that separates the particles by size. Figure 1 shows a portion of a typical slurry separation plant used on microtunneling projects. This photo shows the "coarse screen" on the plant that retains the largest particles that are within the slurry.

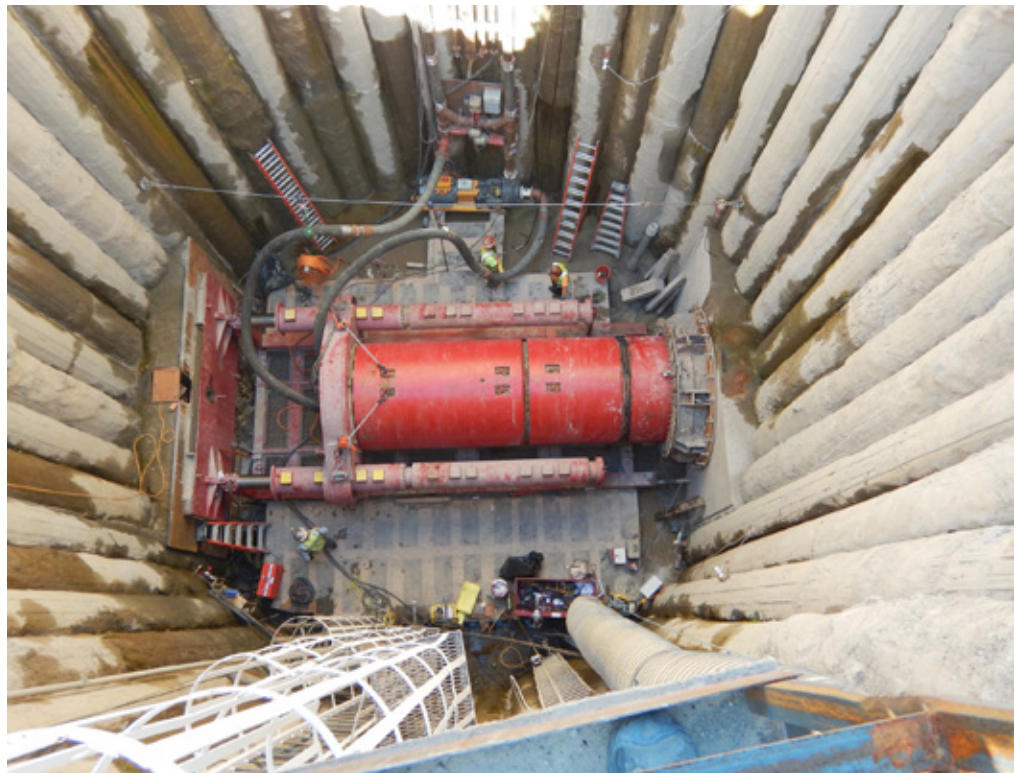
Figure 2. Launch Pit

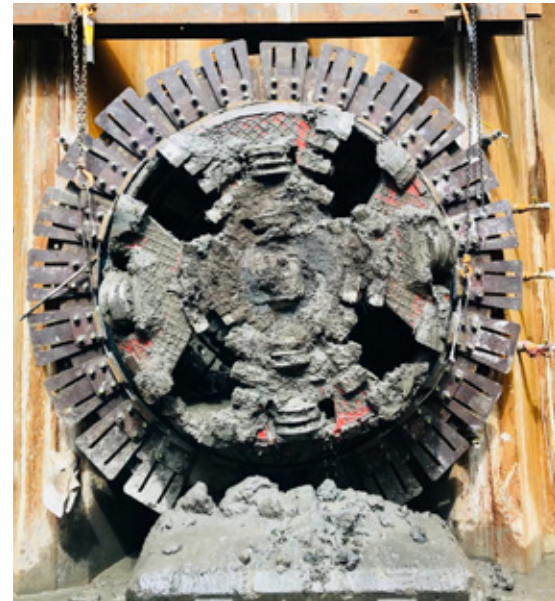
Figure 5. Hole Out

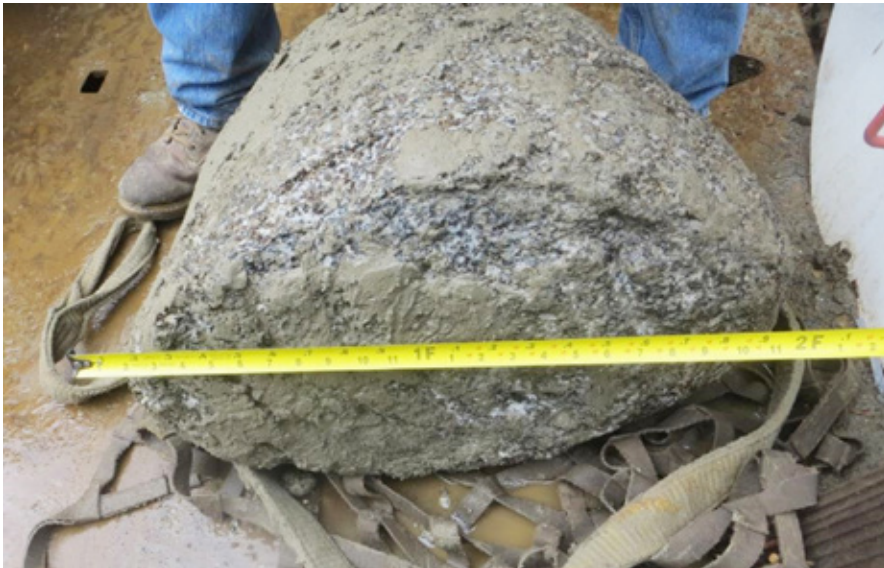
Figure 6 Boulder that was recovered from machine face. Note the tape measure is for scale. The largest dimension was measured with calipers that could measure up to 36-inches

During construction, the specialty trenchless inspector collected information on the boulders that were encountered and what means were necessary to remove the boulders and resume tunneling. During
