# MID ATLANTIC JOURNAL OF TRENCHLESS TECHNOLOGY 2021

### 12 Formidable Pipe Geometry Overcome with First-Ever Breakthroughs

### 24 Baltimore City Water Main Repair Using CFRP Wrap

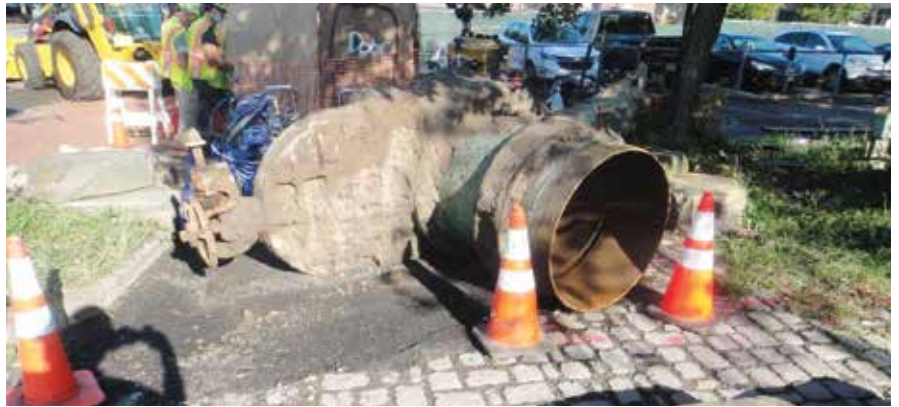
36-inch Valve was excavated on the east side of the "The Mess" to form the Receiving Pit for liner inversion

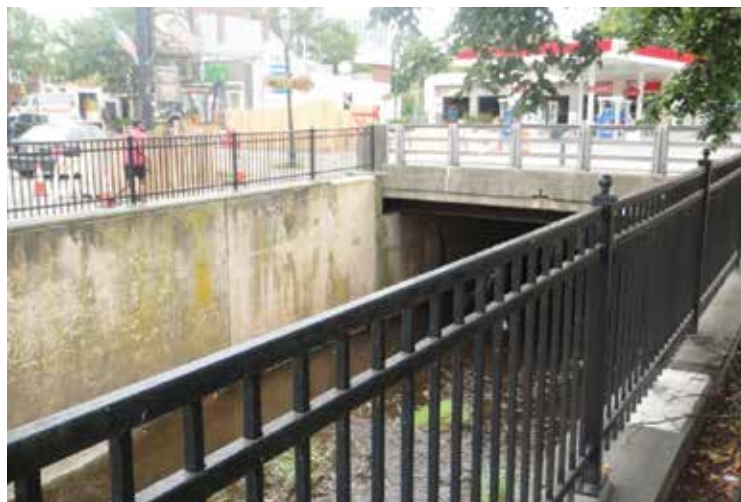
Pipe configuration of "The Mess" was built in 1971 when the Rahway River in South Orange NJ was encased in a concrete channel and the bridge widened

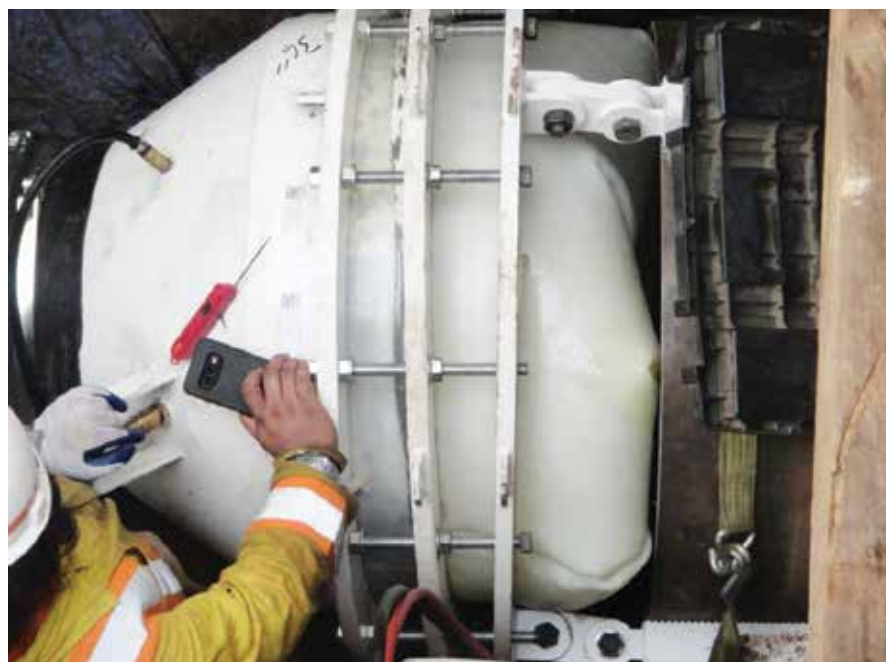
36-inch Guide Pipe was essential to ensure 36-inch liner was aligned correctly as it traveled through the 30-inch segment

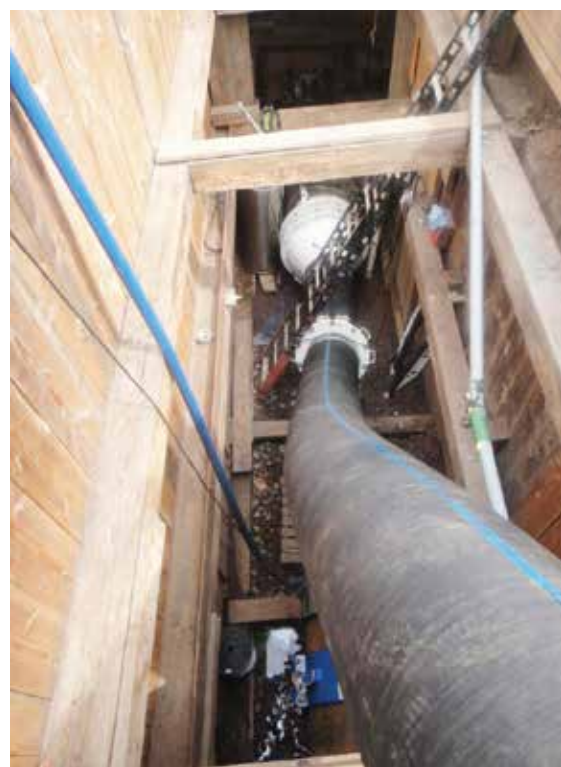
*Transport hose used to convey inverting liner down into 10-foot deep pit. This innovation eliminates chafing during liner entry and is referenced as the “US Method”*

Due to the tight complicated geometry within the short 175-foot length of pipe, there was substantial concern that the retention belt would chafe holes in the liner, especially at the furthest end of the alignment, where the liner inverted through the final three bends. This concern was addressed by making the retention belt as narrow as possible, and heavily lubricating it. As a result, there was no abrasion or any damage to the liner from the retention belt throughout the inversion.

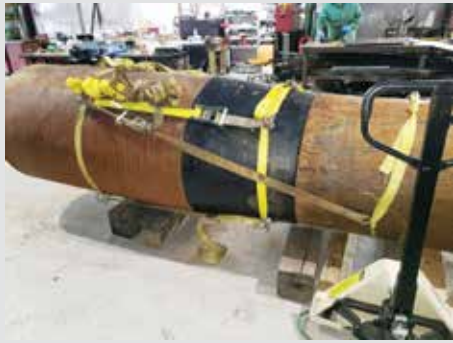
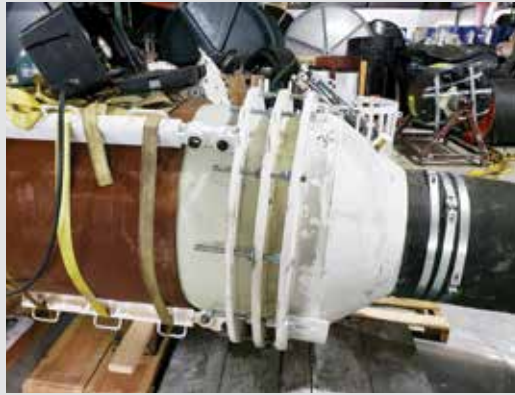
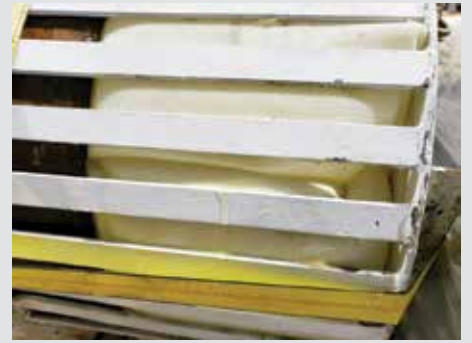
Extensive shop testing of the Guide Pipe and Reducer configuration ensured that the liner would traverse the obstacles and invert properly over the entire length of "The Mess"

Before inversion, extensive shop testing was performed on the guide pipe and reducer configuration before it was installed. The tests confirmed that minimal wrinkles in the liner were structurally sound and did not create any breaches in the liner integrity. Correctly aligned by the guide pipe, the liner was able to invert properly throughout the entire length of 36-inch steel pipe after first traveling through the complicated 30-inch section. First time this has ever been done.

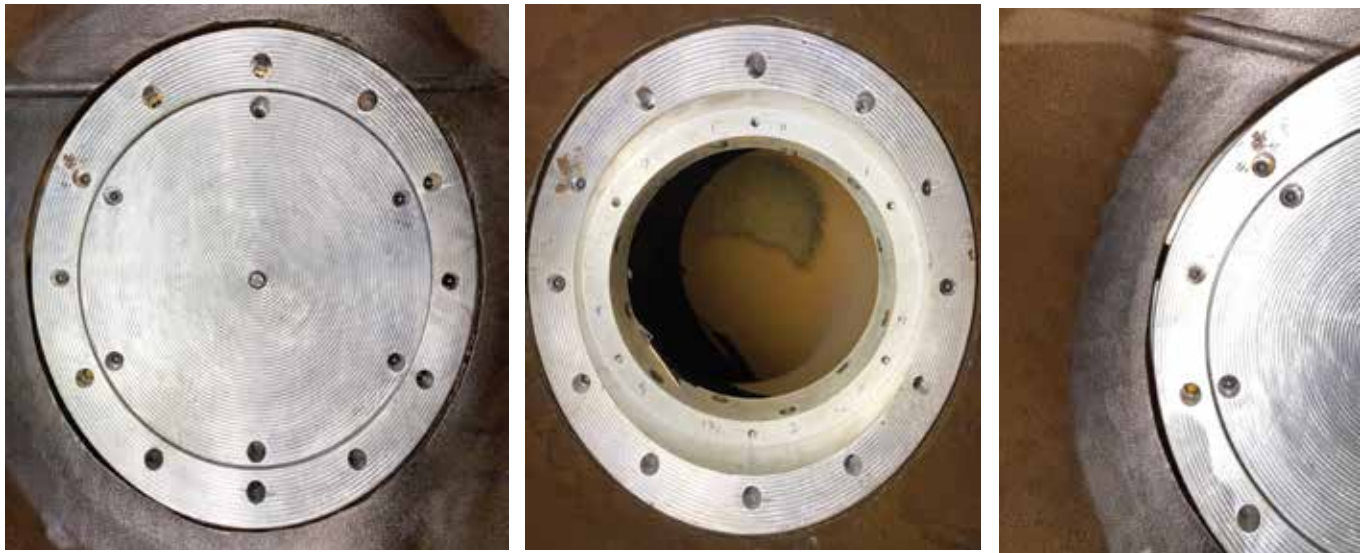
*Design engineered prefabricated metal plug installed to cover a 20-inch lateral and provide bearing surface for liner inversion*

First-ever design and installation of a prefabricated metal temporary restraint plug used to plug-off a 20-inch diameter lateral located at a 13-foot depth that had to be subsequently reopened by cutting the liner back after a successful pressure test. This prefabricated restraint plug played a key role in providing a bearing surface to prevent liner rupture upon liner installation and pressure test. The liner was cut away, and the restraint plug removed entirely once the liner had cured in order to allow gas to flow up into the lateral. Prior to this work, a Miller Pipeline crew had used the opportunity to Weko-Seal the abandoned 20-inch lateral.

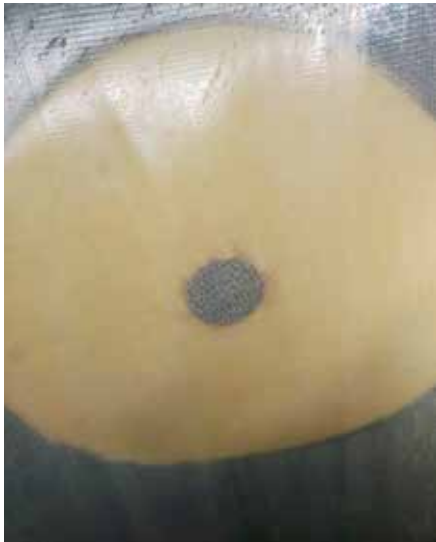
*Liner was cut away, plug removed and 20-inch lateral restored after curing*

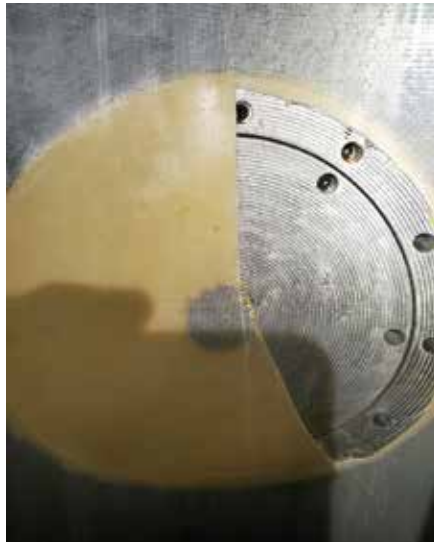
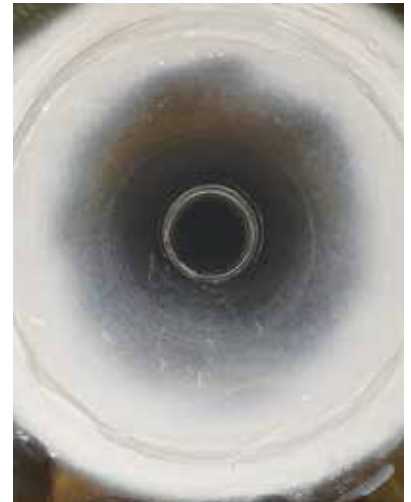
*Application of high-strength heated epoxy spray to reinforce and seal leading 36x30-inch reducer was a breakthrough technical accomplishment*

First-ever use of high-strength epoxy spray to reinforce a leaking 36x30-inch reducer by spraying a 0.25-inch layer of epoxy on the entire ID of the fitting prior to lining, to reinforce and add strength to the fitting, which was the final

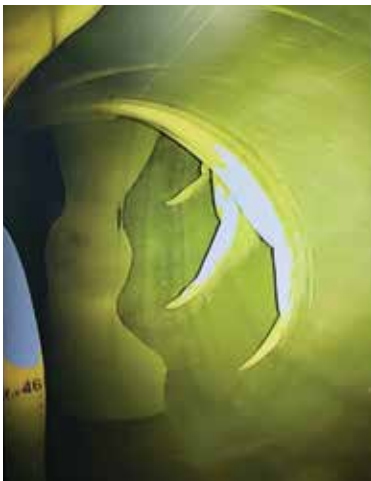
*Elbow fabricated from high-strength epoxy was crucial in allowing liner to navigate compound curve with minimal wrinkling*

First-ever use of high-strength epoxy to fabricate a 90-degree bend out of a 36x36-inch tee as part of a stack drip geometry to facilitate liner installation through the fitting. Normally this legacy fitting would have been replaced with a 90-degree elbow, however the fitting was 15.5 feet deep and located in an area containing monitoring wells due to prior gas station tank leaks.

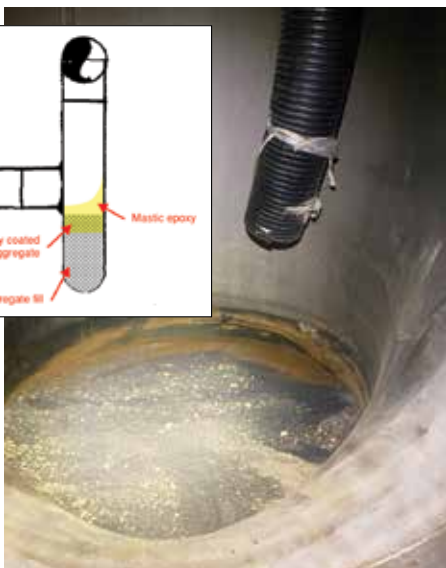
*Stack was backfilled, then covered with mastic epoxy to form a 90-degree elbow from the 36x36-inch Tee*

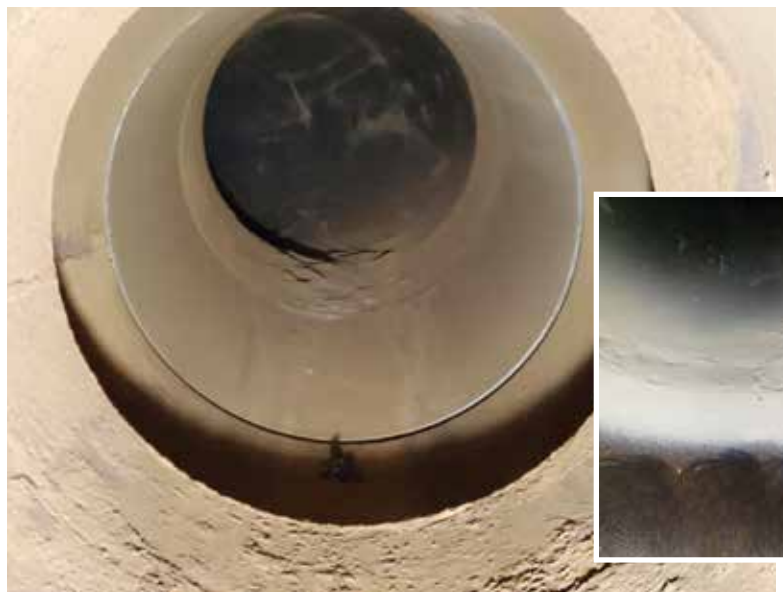
*Use of aggregate and mastic epoxy to bridge 30-inch valve gate well was done for the first time ever*

After the cleaning process was completed, the A&W Maintenance subcontractors moved onsite and completed bridging the gap of the gate valve well with high strength epoxy to provide a bearing surface for the liner, and also sprayed the interior of the leaking 36x30-inch reducer, as detailed above. The most critical part of their work involved the transformation of the stack drip tee to a 90 bend which had to be hand-troweled. The epoxy cured over the weekend, and the necessary lining of “The Mess” was completed on the following Monday, August 31.

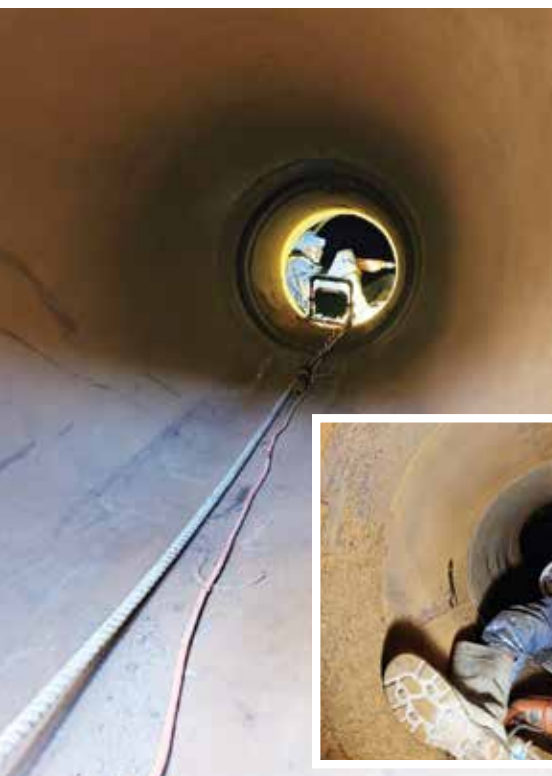
*Injected curtain grouting into the surrounding soil from the interior of the pipe was again used to prevent water entry into the depressurized main*

innovation becoming a regular important step in the process of preparing the pipe for lining, where there is a chance of water intrusion entering depressurized pipe. Injected curtain grouting guarantees a dry interior for sandblast cleaning the pipe, and ultimately ensures a smooth lining process by eliminating excessive moisture penetration, which is the primary cause of liner disbondment during inversion.

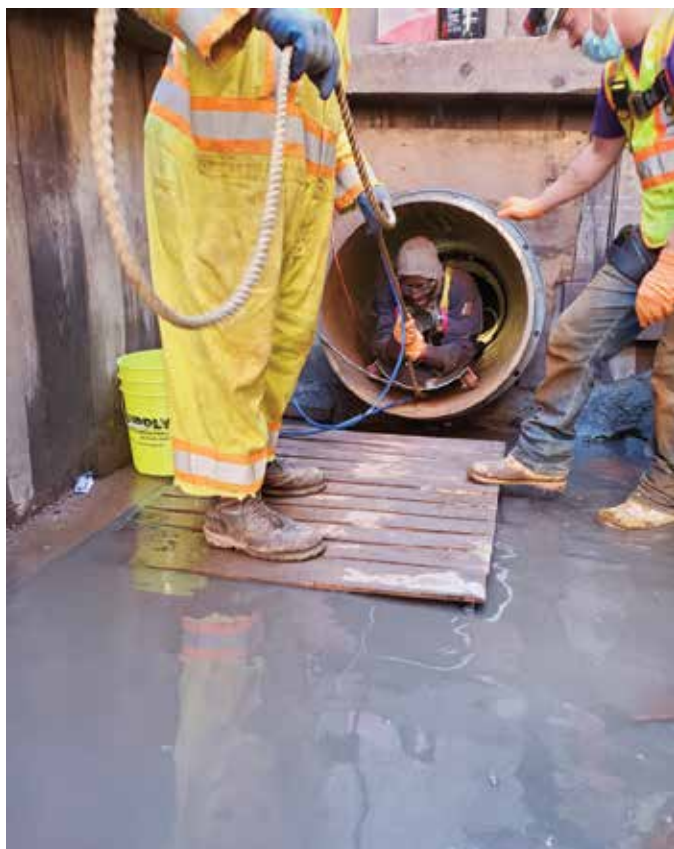
*Confined space entry with extensive safety precautions was necessary for several preparatory steps prior to lining*

For “The Mess”, confined space entry was again required to install the grout from the interior of the pipe. Extensive safety precautions were used including rescue harnesses, fresh air circulation, gas monitoring equipment and a confined space rescue team onsite. A body board and pulley system transported workers down into “The Mess”, and then grout was injected into the soil surrounding the pipe by pumping it from the pipe interior through check valves in holes drilled into the pipe. The grout was allowed to cure over the weekend, and on Monday August 24 the excess grout was removed, and the check valves were ground flush with the inner pipe wall and filled flush with epoxy.

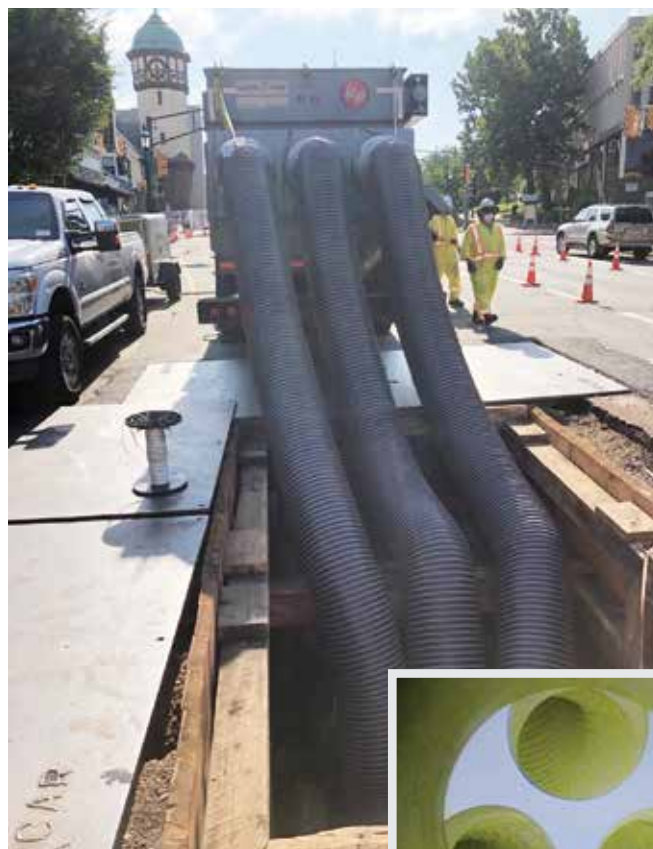
*Dust collector with three 16-inch hoses was used to recover leftover cleaning grit*

Cleaning began immediately on Monday, and, as with the use of curtain grouting, technical advancements first used during the cleaning phase in the world record 42-inch CIPL the previous year were an essential element in getting “The Mess” ready for lining. The dust collectors and 16-inch inlet hose configuration was used again and generated sufficient airflow to remove any grit leftover from the sandblast cleaning.

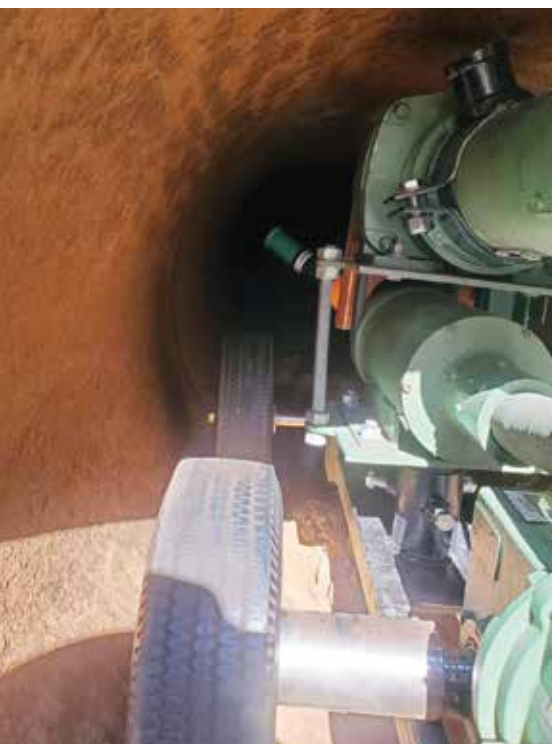
*Self-propelled robotic sandblast unit nicknamed "The Beast" was again used to clean the pipe interior before lining*

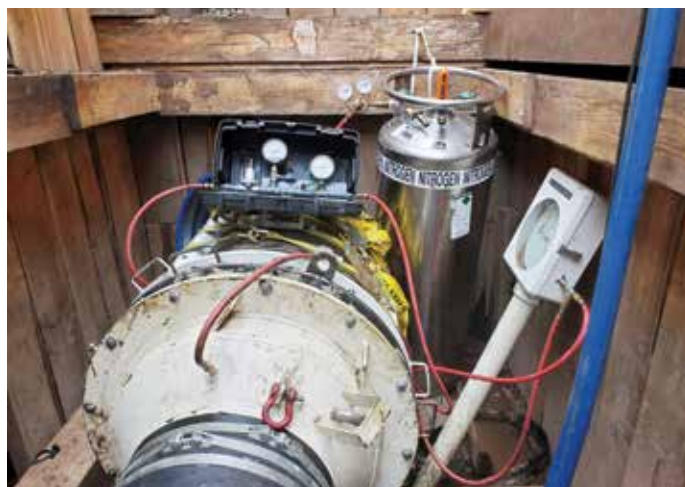
*Liner ambient cured with nitrogen supplied as make-up air*

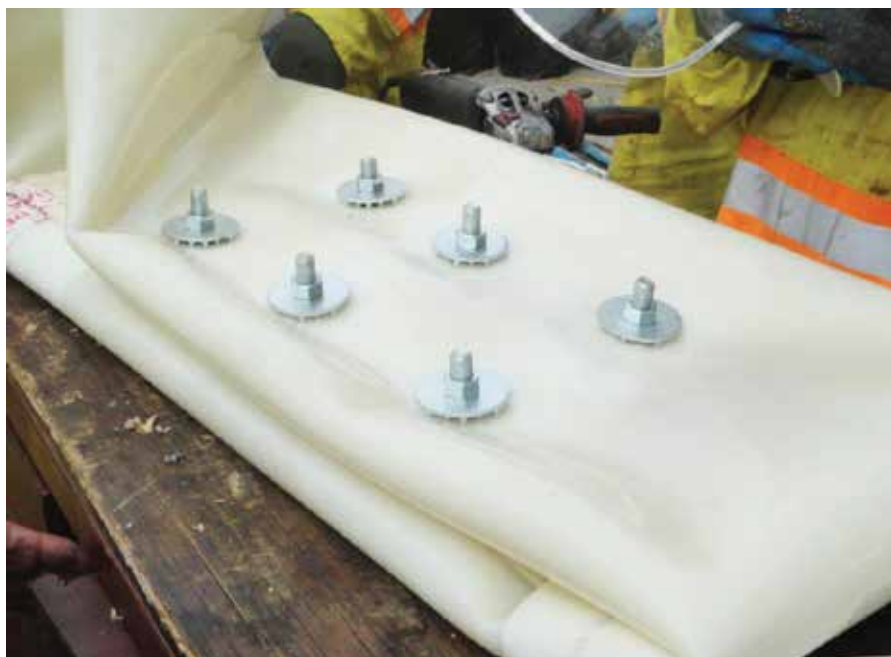
Liner with six tail bolts

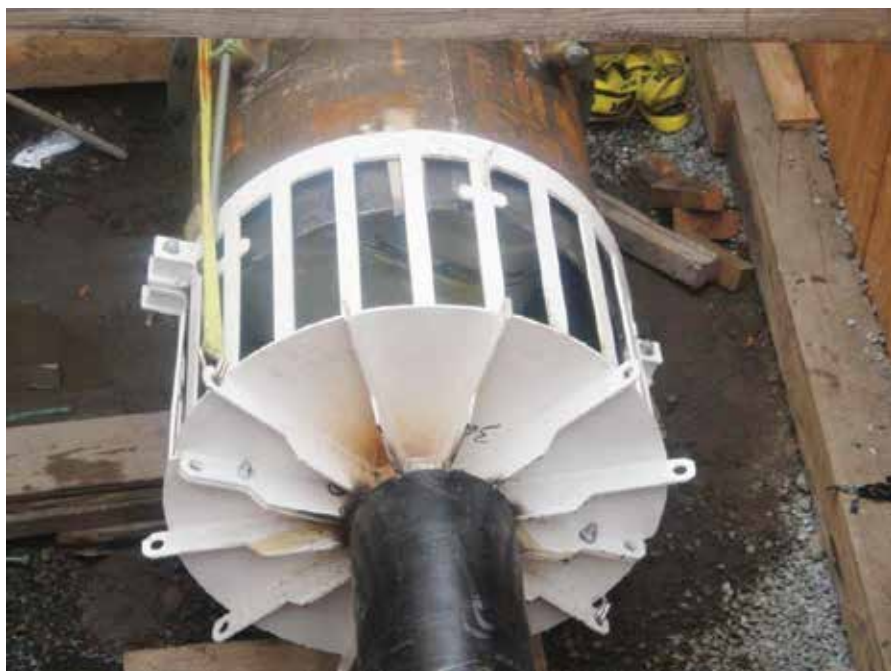
Inversion of the liner through "The Mess" took less than two hours

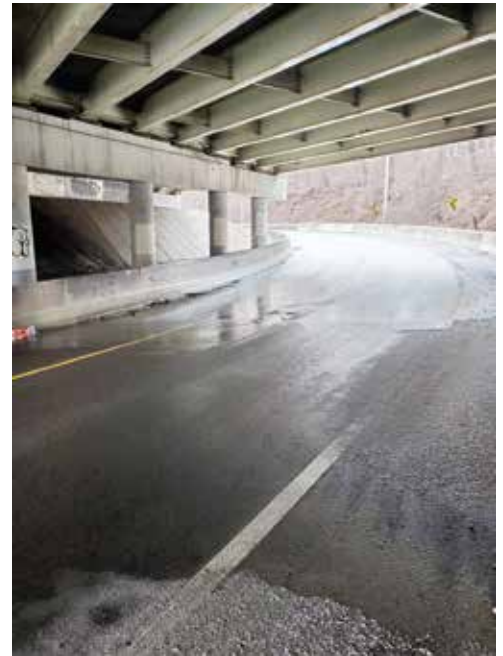
Figure 3. Water main breach was flowing onto the South Bound offramp to I-83, creating hazardous conditions

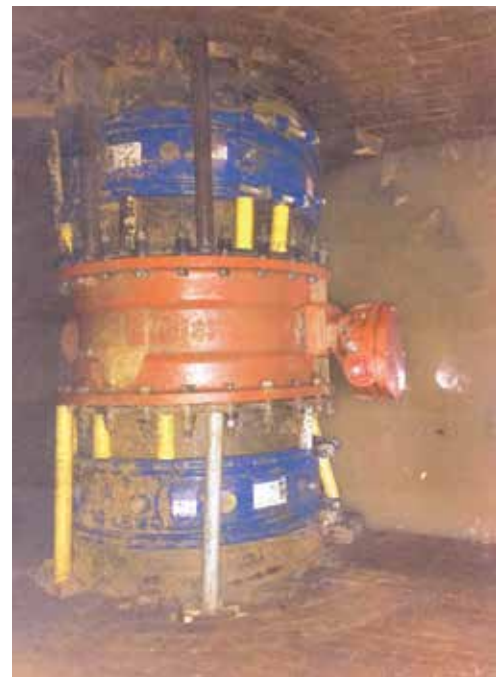
Figure 4. Temporary bracing was used to restrain the new 36-inch butterfly valve while the repair was underway

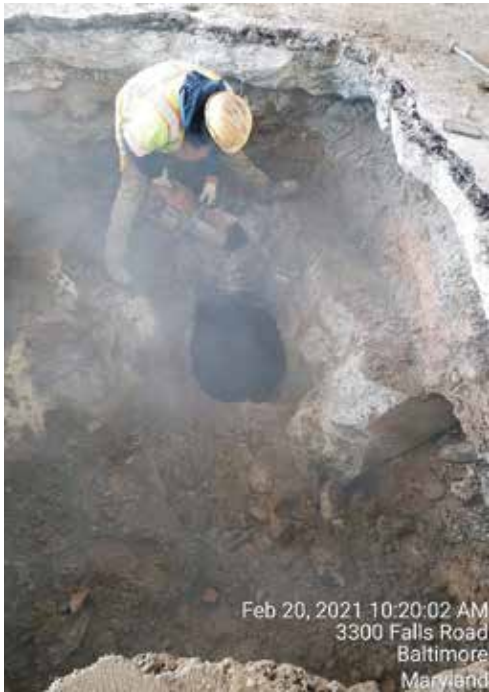
Figure 5. A two-foot hole was cut into the water main to inspect for further damage

damaging the 48-inch PCCP water main further. The contractor exposed the PCCP leak and discovered a crack in the steel cylinder that was the source of the water leak. The contractor cut a 2-foot hole into the water main and inspected the area for further damage.

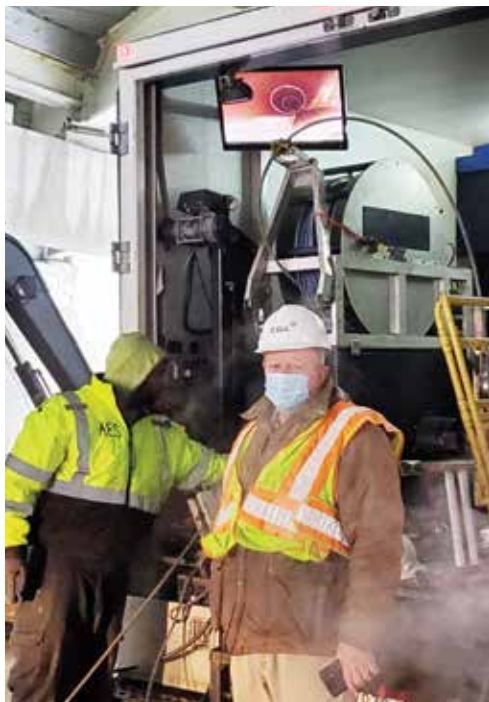
Figure 6. CCTV inspection of pipe in vicinity of the leak required installation of two entry ports

EBA also recommended CCTV inspection of the pipe near the leak to determine any other defects. AES

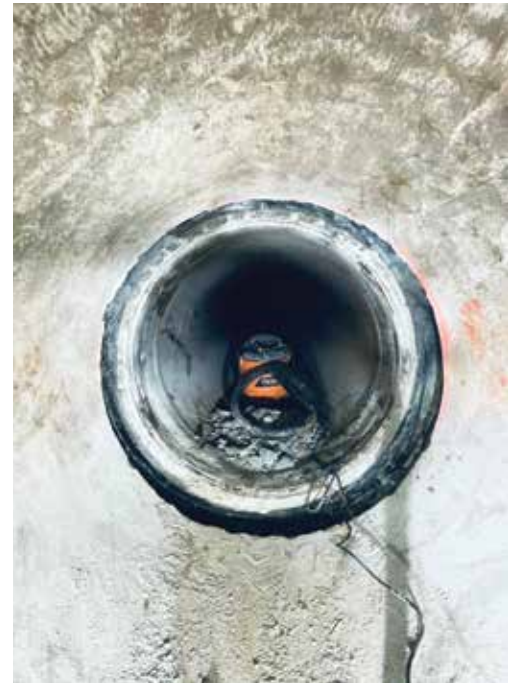
Figure 7. Surface preparation

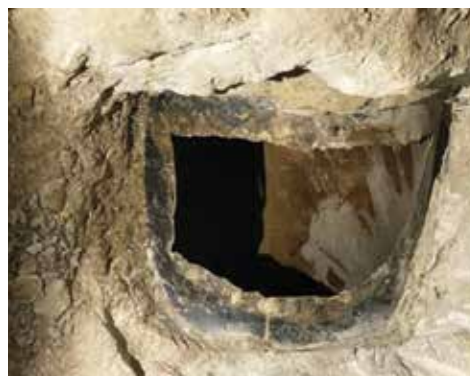
Figure 11. The steel plate was designed to fit the curvature of the pipe to ensure it fit to the cylinder

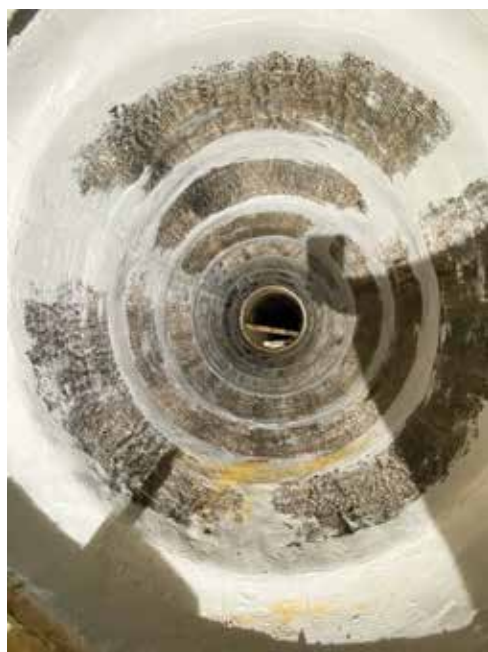
Figure 9. Completed CFR of the 48-inch pipe

The second option was to use carbon fiber (CFR) to repair the total length of the 48-inch PCCP. This option provided the necessary structural integrity and appropriate pressure rating, and it could also be installed using the access point 300 feet away. The City already had the specifications for this CFR option. Therefore, the City selected this option as the best long-term solution.

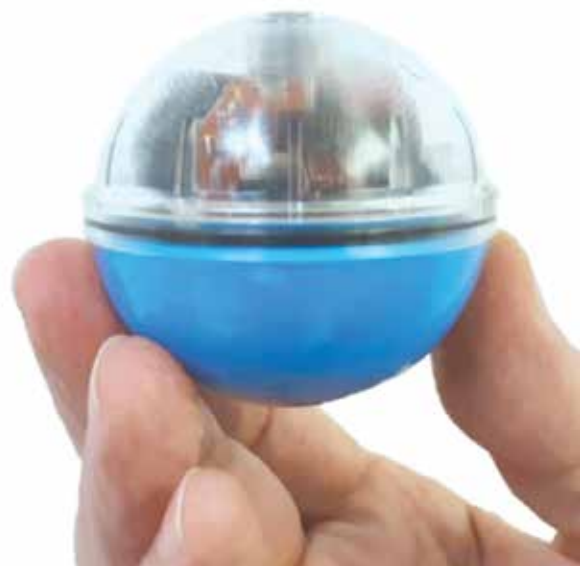
Figure 1. The INGU “Piper”

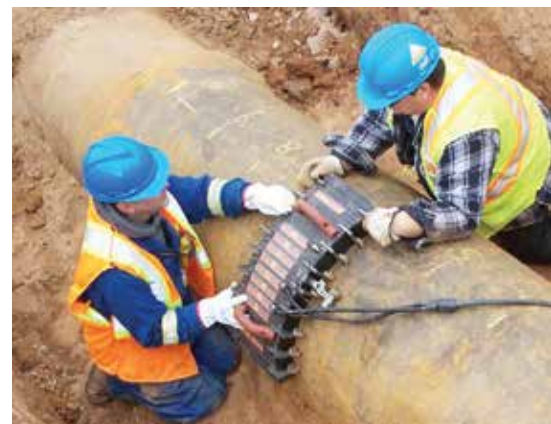
Figure 2. The “Bracelet Probe”

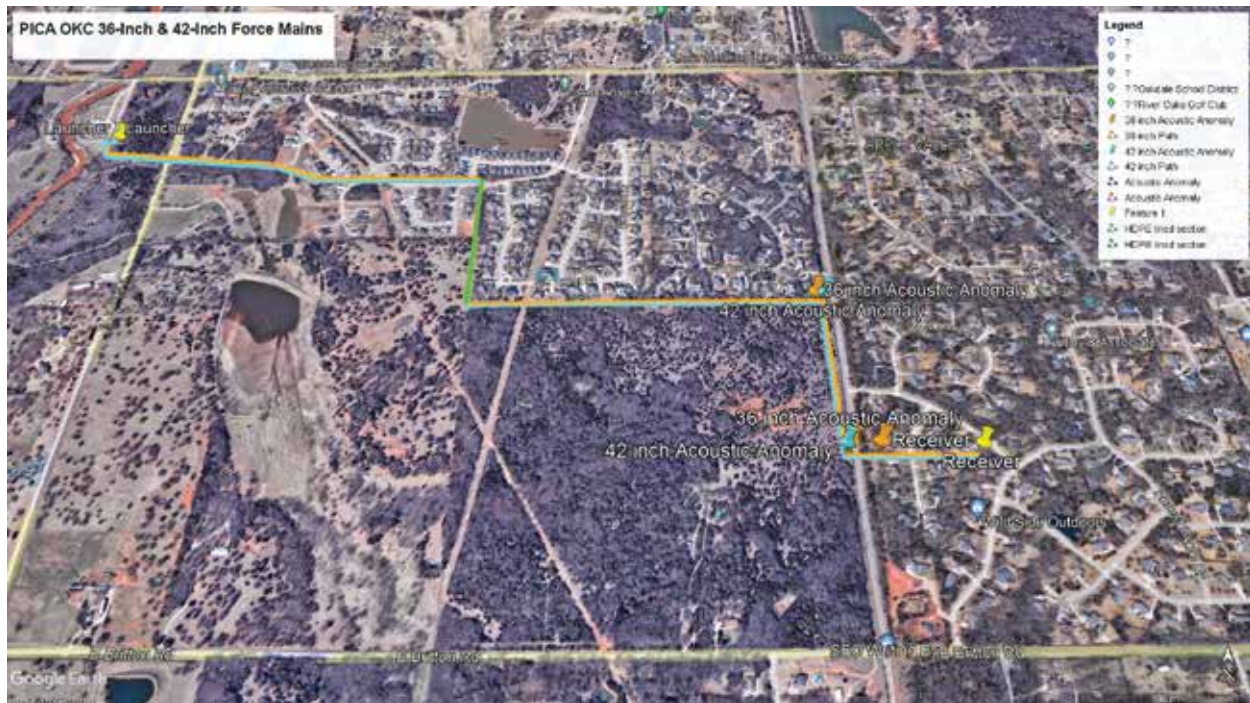
Figure 3. Identifies the inspection area of the twin force mains. The area located in the Green had been previously rehabilitated. The acoustic anomalies are identified with pins on each line

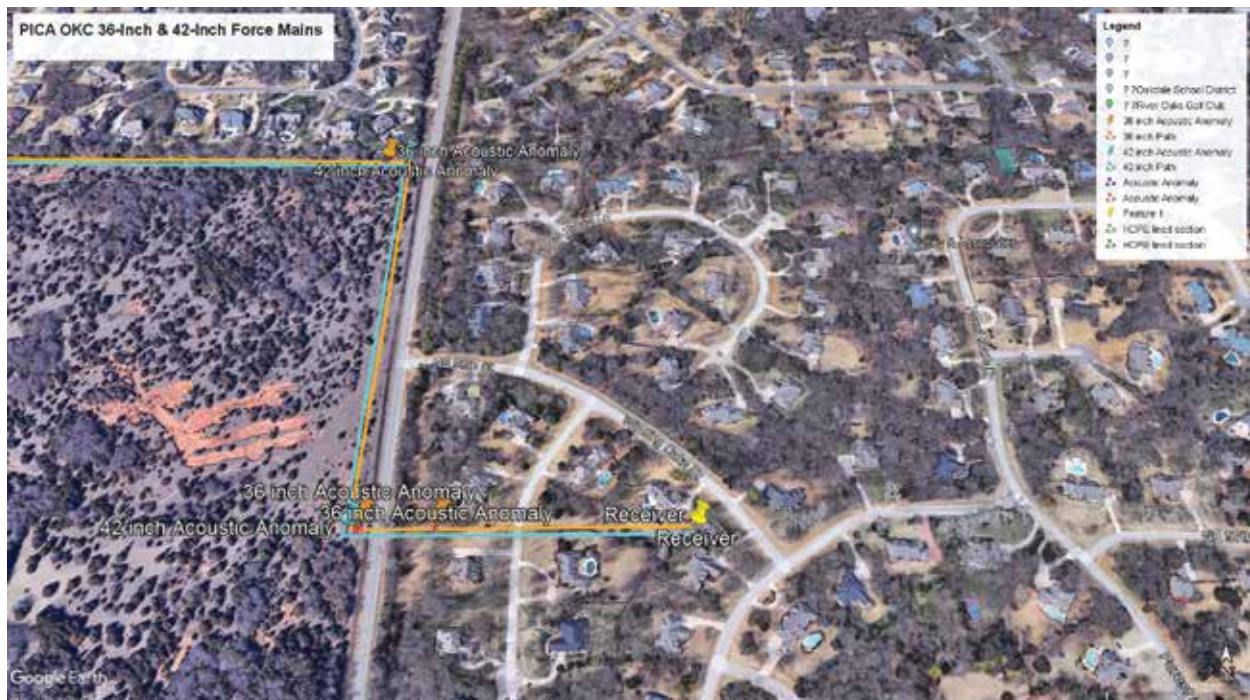
Figure 4. Zoom of the pipeline section of the 36-inch and 42-inch force mains with the acoustic anomalies. Based on the locations and confirmation of the air-pockets OKCWUT will perform external validations utilizing the PICA Bracelet Probe (Figure 2) to identify the wall loss in these areas and determine the RUL (Remaining Useful Life) of this critical asset
