BC's Magazine for Trenchless Construction

First Live Sanitary Sliplining

Taking A Shot in Richmond

Coastal GasLink Pipeline - Murray River HDD

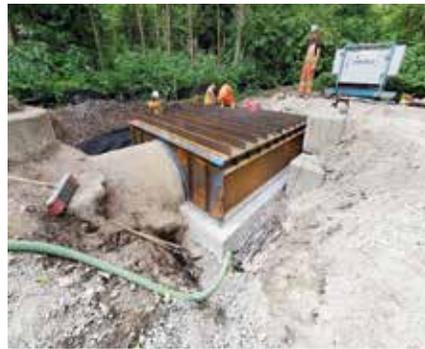
The project was in 4 sections going from upstream.

- > **Section 1** was from a chamber that received sewage from a twin syphon and that section was 15m long and straight from the chamber to an intermediary pit.

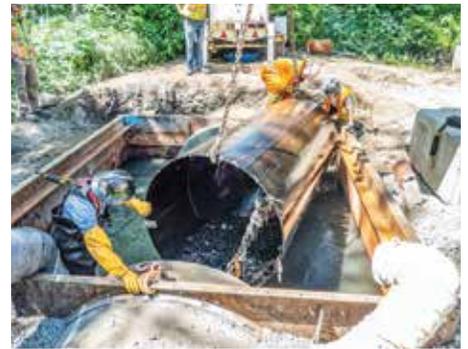
- > **Section 2** turned out to be curved with joints pulled for 100m, from that intermediary pit to a manhole, more on that later.
- > **Section 3** was a 100m straight from manhole to manhole.
- > **Section 4** was 19m from a manhole to a blind end.

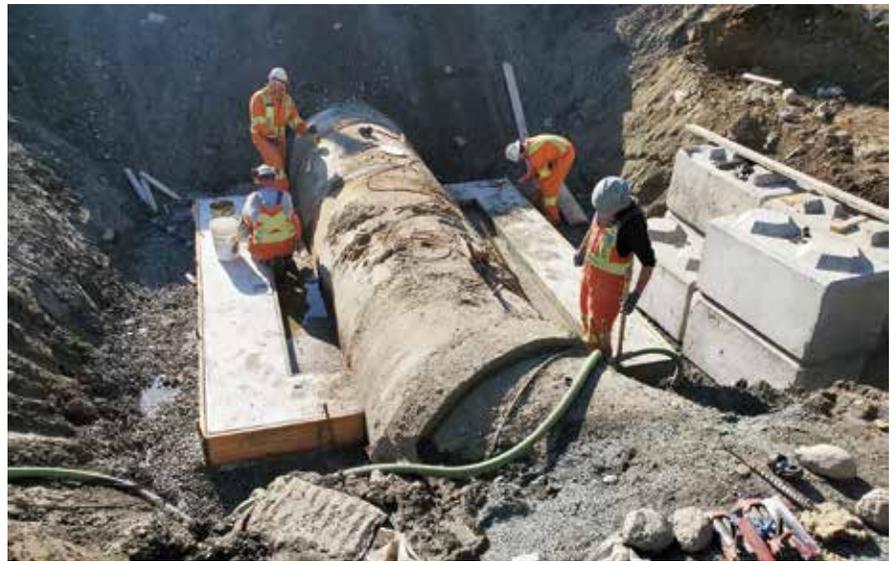
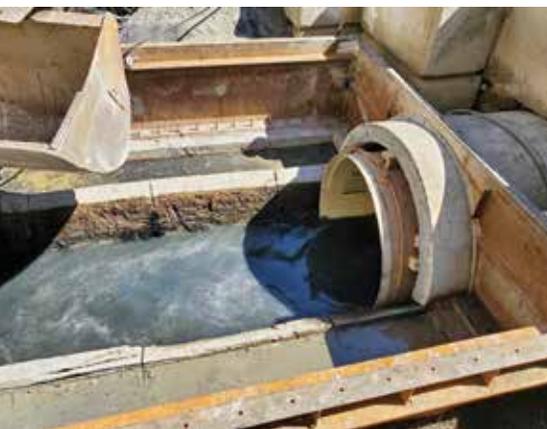
On **Section 2** as all the existing pipes were laid in a curve it meant that we had to push our GRP around a corner.

There were concerns that because we expected the joints to open and close as the individual GRP pipes negotiated the numerous 2.4m tangents that some joints would open more and beyond the gasket. We were successful and all performed as required.

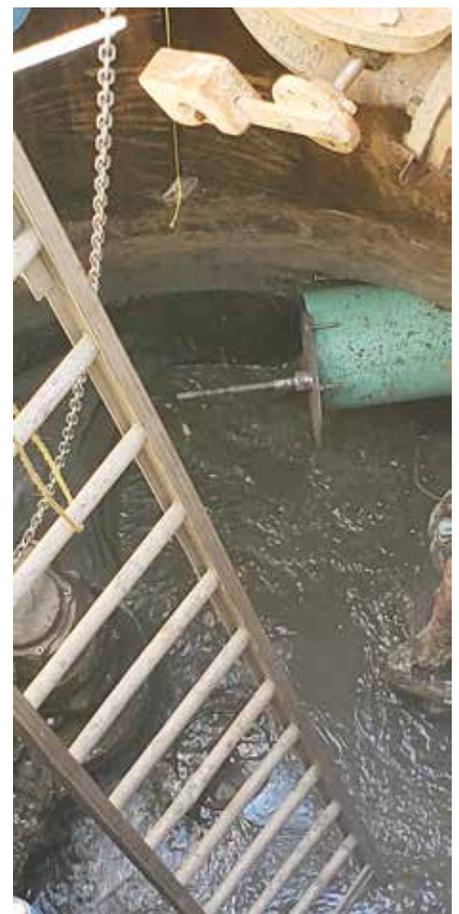
Installed 750mm pipe section with ready rod 'clamp'. Note 'awkward' position of pipe entering pump station

David O'Sullivan of PW Trenchless proposed attempting the repair by sliplining and microbursting a new 300mm diameter PVC pipe using about 20 pieces of custom-made 750mm long sections with a modified bell and spigot joint, reminiscent of an old-fashioned woodworking tongue and groove joint to avoid having to fuse the pipe sections under wet confined space conditions. To ensure good connections between the pipe sections after installation, a 16.4m long ready rod from the newly installed sections to the MH was added to act as a clamping devise to hold the new pipe sections together while giving the glue a chance to cure.

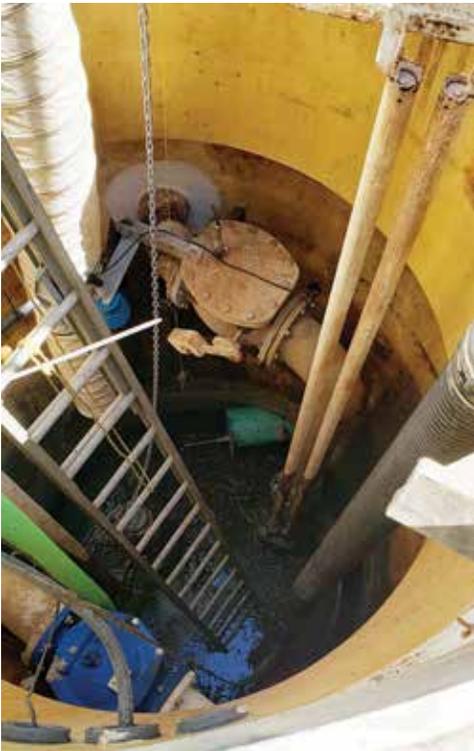
Depth of the repair work about 5 metres down

It would be a simple matter to repair the breach using open trench methods were it not for the multiple services between the failed pipe and the road surface about 5 metres above it including but not necessarily limited to two twin Metro Vancouver 900mm trunk sewers, a 600mm storm sewer, a 300mm watermain, a 300mm sanitary forcemain, a Fortis gas line and possibly a BC Hydro distribution cable.

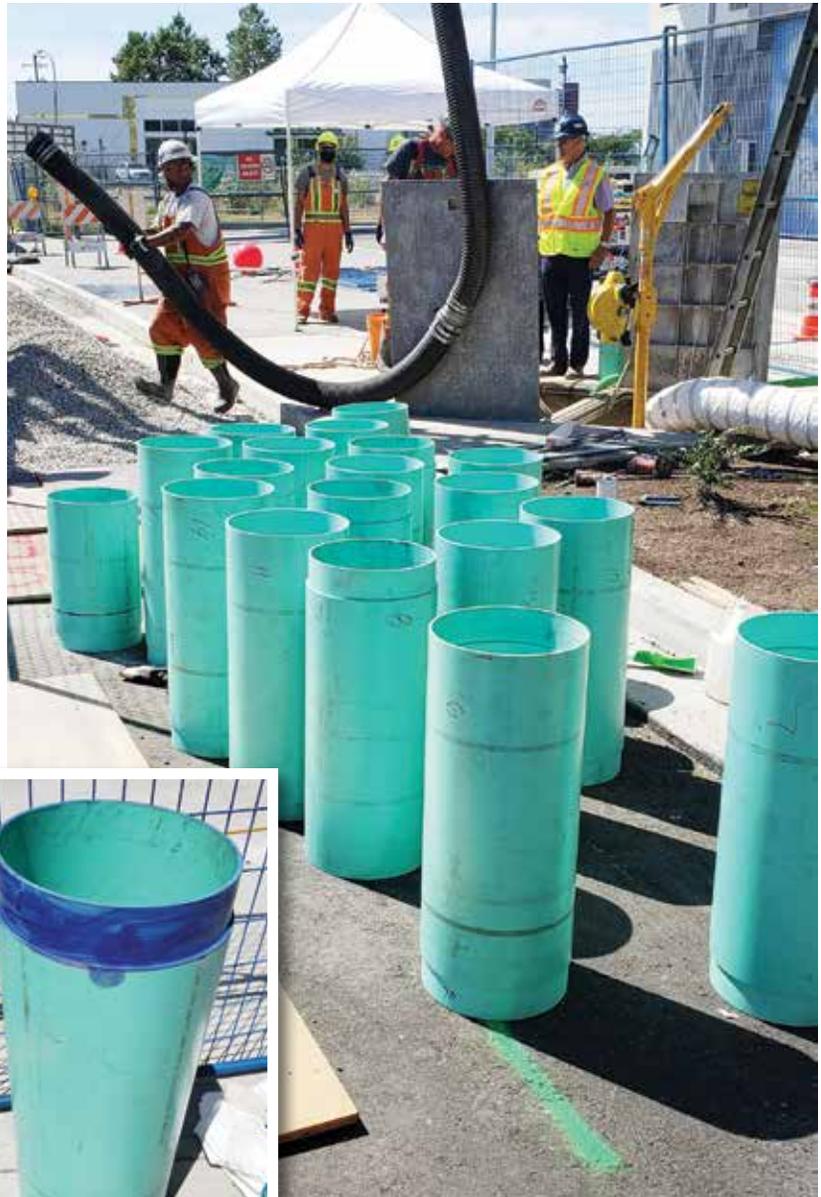
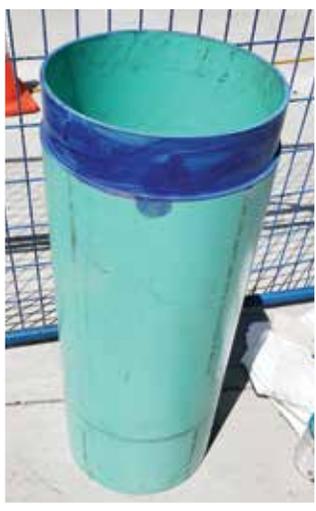
Custom 750mm PVC sections - note the modified bell and spigot joint

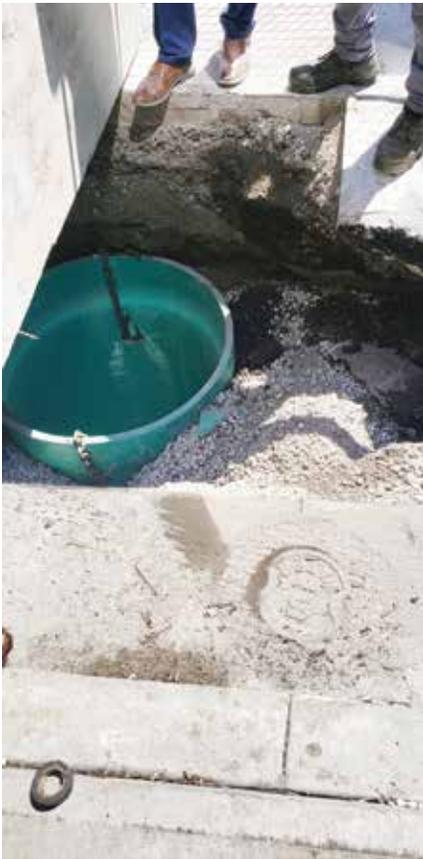
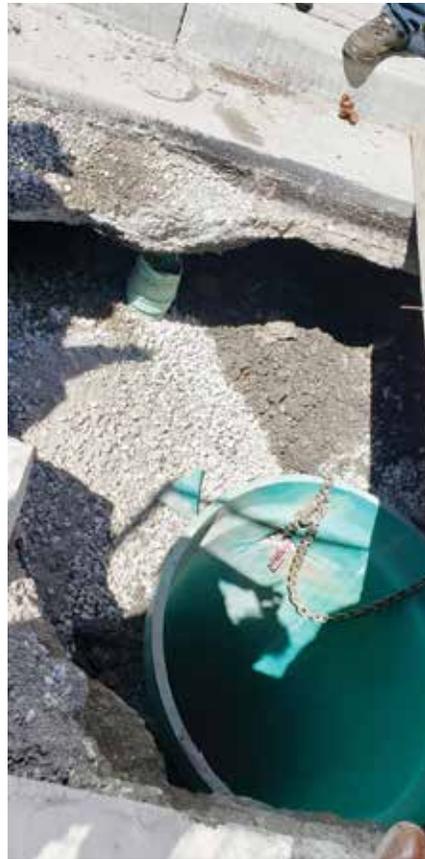
Sinkhole caused by migrating fill

The second reason for the keeping the site shut down for further evaluation was the discovery that somewhere between 5m³ - 9m³ of material had infiltrated the breach and migrated back through the breached pipe into the pump station. This unanticipated movement of fill explains the large sinkholes shown in the attached photographs. Although this material was easily removed from the pump station the concern is the alarming volume of material migrating below the surface possibly creating risk to the other services in the immediate vicinity of the breach and

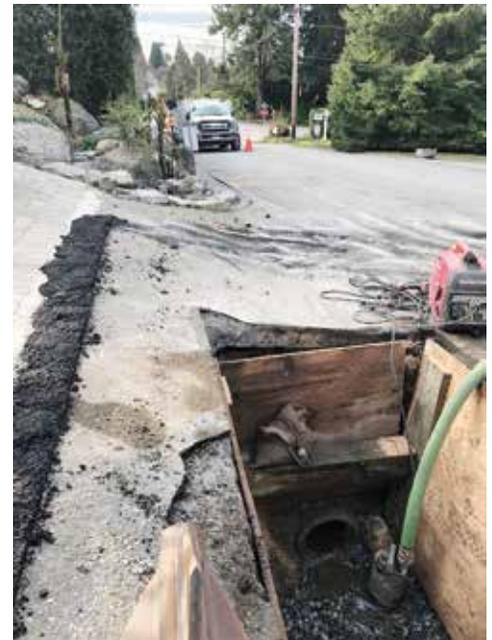
Static Pipe Bursting, West Vancouver

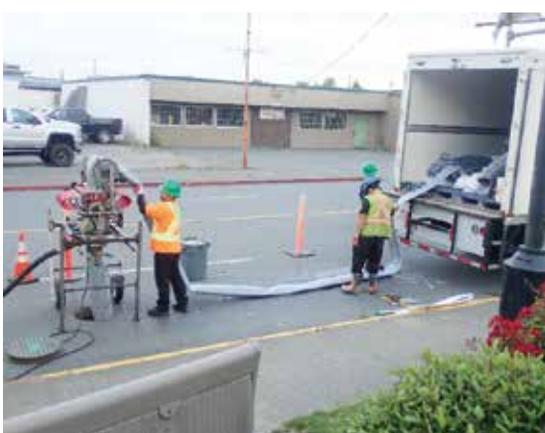
Cured In Place Pipe, Campbell River

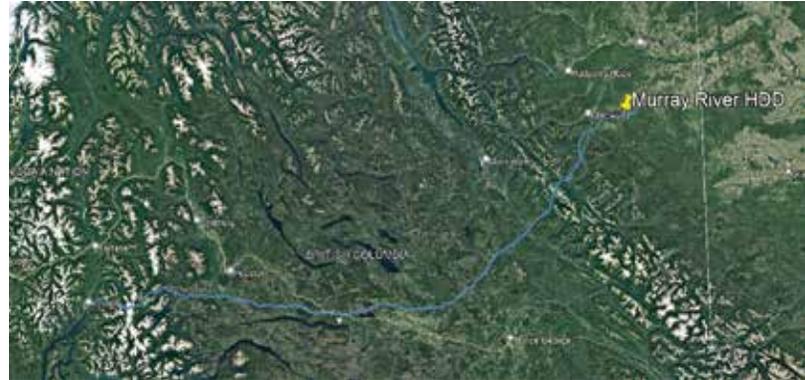
Figure 1. CGL Alignment and Murray River Crossing Location

This paper is a review of the design, development and construction of the Murray River HDD. The crossing location along the CGL alignment (blue line) is shown in Figure 1.

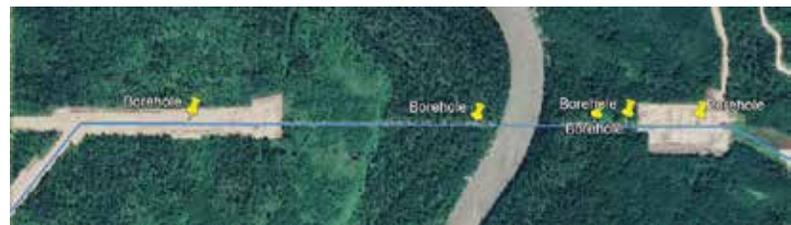
Figure 2. Murray River Crossing Alignment

The CGL alignment crosses the Murray River from east to west near a bend in the river, as shown in Figure 2. The Murray River flows from south to north at the crossing location with a channel that is approximately 100 m wide. The banks are steep and approximately 20 m high and the valley containing the river, banks, and sloping floodplain on the west side is roughly 600 m wide.

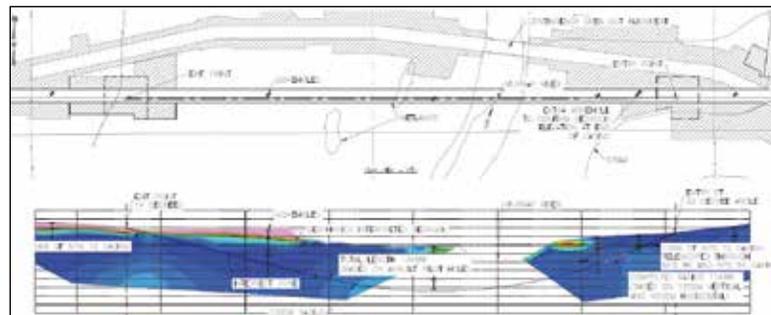
Figure 4. Updated Design Plan and Profile.

During installation, the 108 m of unguided casing deflected from the designed, optimized path. A 2-degree vertical and 1-degree lateral deflection was measured in the casing as-built survey. This deflection posed a high risk that the pilot hole would not remain within the required design

geometry and meet the radial tolerances over 10 m and 30 m increments. A redesign of the HDD was required and incorporated a compound radius, a lateral shift in the drill alignment, and the removal of the tangent portion of the drill path between the entry and exit build sections. The tight radii led to an increased schedule required for the pilot hole, though TCC was able to complete the intersect within specifications based on the updated design.

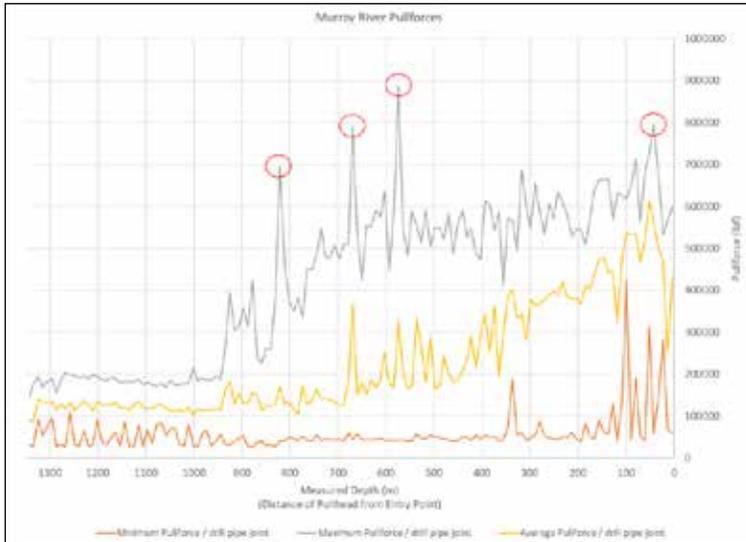
Figure 5. Murray River observed Pull forces

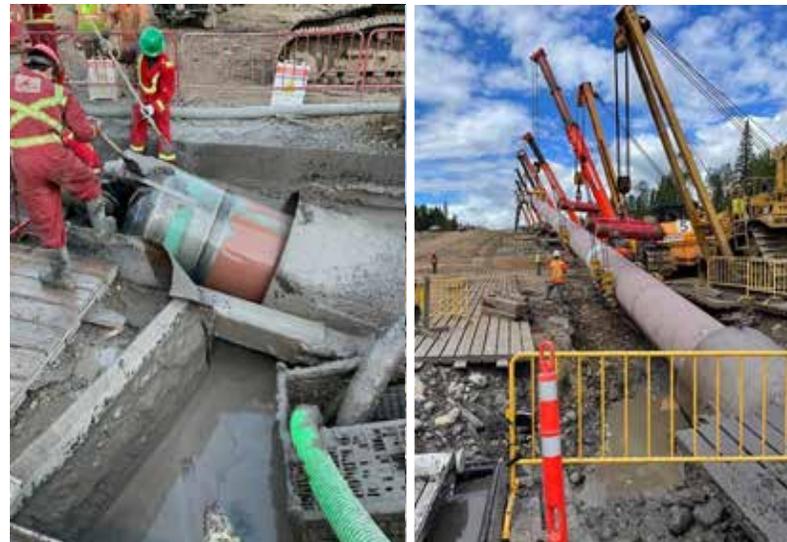
Figure 6. Pipe pulled in. PHOTOS PROVIDED BY CGL.

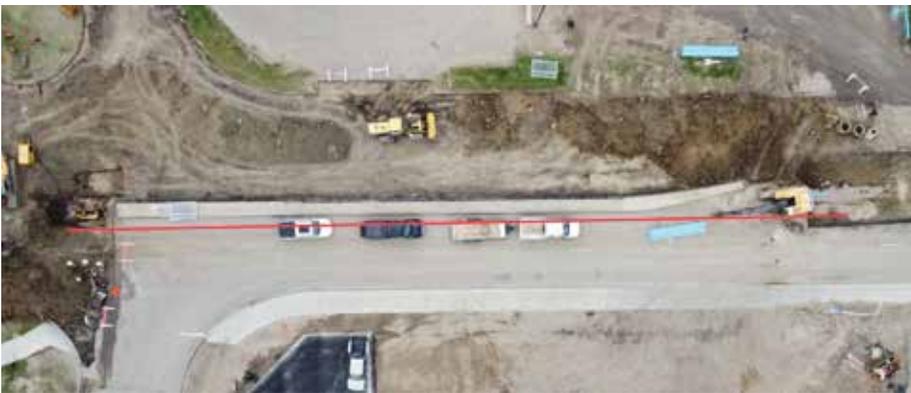
Figure 2. Aerial View of 200mm (8 in) Sanitary Pipe Bursting Installation – 62nd Avenue

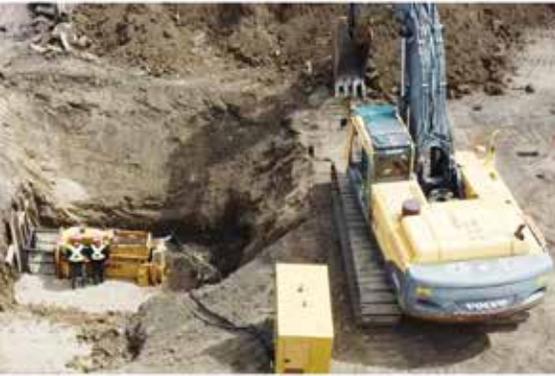
Figure 3. Aerial View of Static Pipe Bursting Machine and Machine Pit– 62nd Avenue

The machine pit was excavated at the north end of 62nd Avenue and was approximately 4.5 m (15 ft) long. The static pipe bursting machine used was a Hammerhead HB-125 model and was operated by the pipe bursting subcontractor, 3D Pipe Bursting. The machine was placed in the pit using an excavator and the hydraulic power pack was placed above the pit, pictured in Figure 3. The HB-125 model is designed for replacement pipes in the range of 150 mm (6 in.) to 500 mm (20 in.) with a max pull force of 125 US tons.

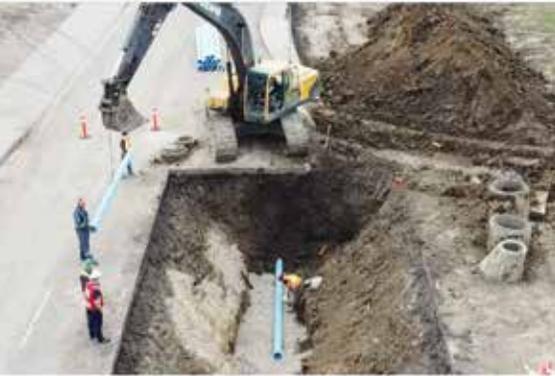
Figure 4. Aerial View of Insertion Pit – 62nd Avenue

were lowered into the insertion pit. The expander was then attached to the bursting rods which had already been fed through the existing pipe. The attachment of the expander to the bursting rod can also be seen in Figure 6. As the first 6.1 m (20 ft) length of pipe was being pulled back, the contractor in the pit assembled the joint.

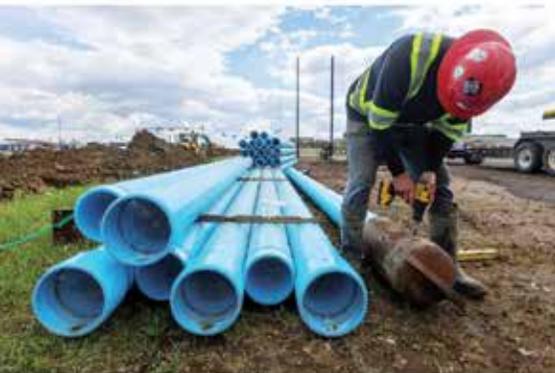
Figure 5. Attachment of Expander Head to the Pipe

The expander used on the project is a two-piece assembly. As shown in Figure 5, the general contractor, Rusway Construction, attached the inside piece of the expander to the spigot end of the pipe. Next, Figure 6 shows the outer piece of the expander, which includes the bursting fins, attached to the inner section. This assembly was fully anchored to the new pipe and ready to be pulled into place. The expander head has an outside diameter measuring several inches larger than the outside diameter of both the existing and new pipes. This allows the hole to be expanded, pushing the soil to the side creating room for the new pipe.

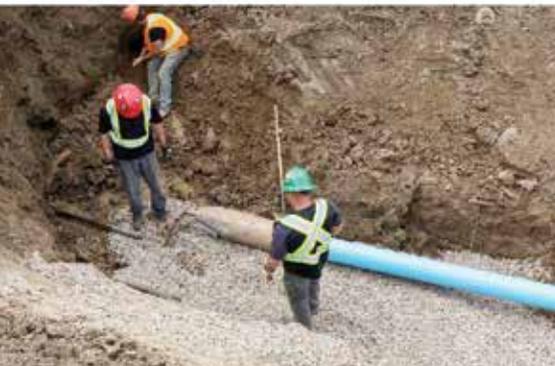
Figure 6. Attachment of Pipe Bursting Expander to Bursting Rods

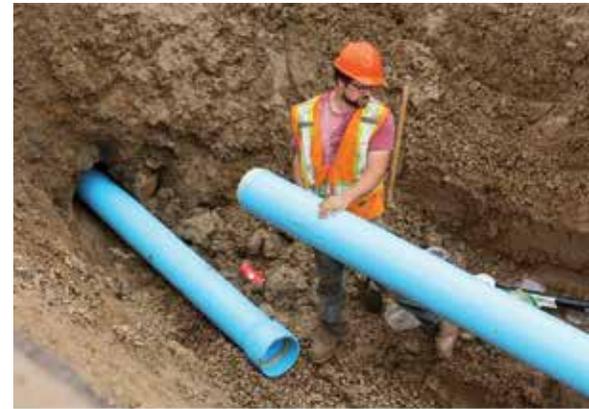
Figure 7. Assembly of Spline Lock PVC Pipe

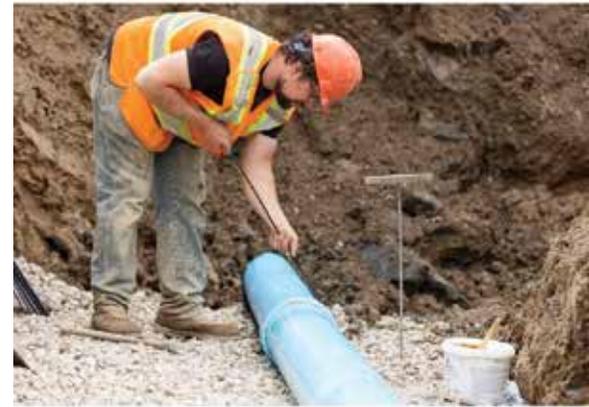
Figure 8. Insertion of Spline into Spline Lock PVC Pipe

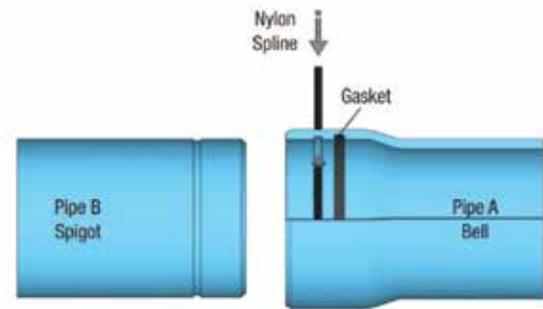
Figure 9. Spline Lock Configuration

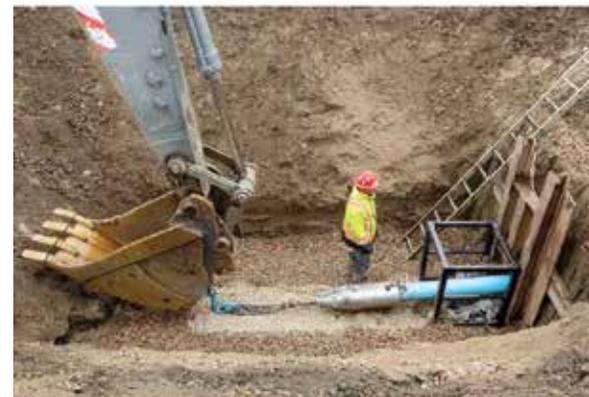
Figure 10. Removal of Bursting Head from Machine Pit
